DIXON WATER FOUNDATION

2021 – ANNUAL REPORT

This report summarizes the efforts taken by Dixon Water Foundation to achieve the goals of their mission in the year **2021**.

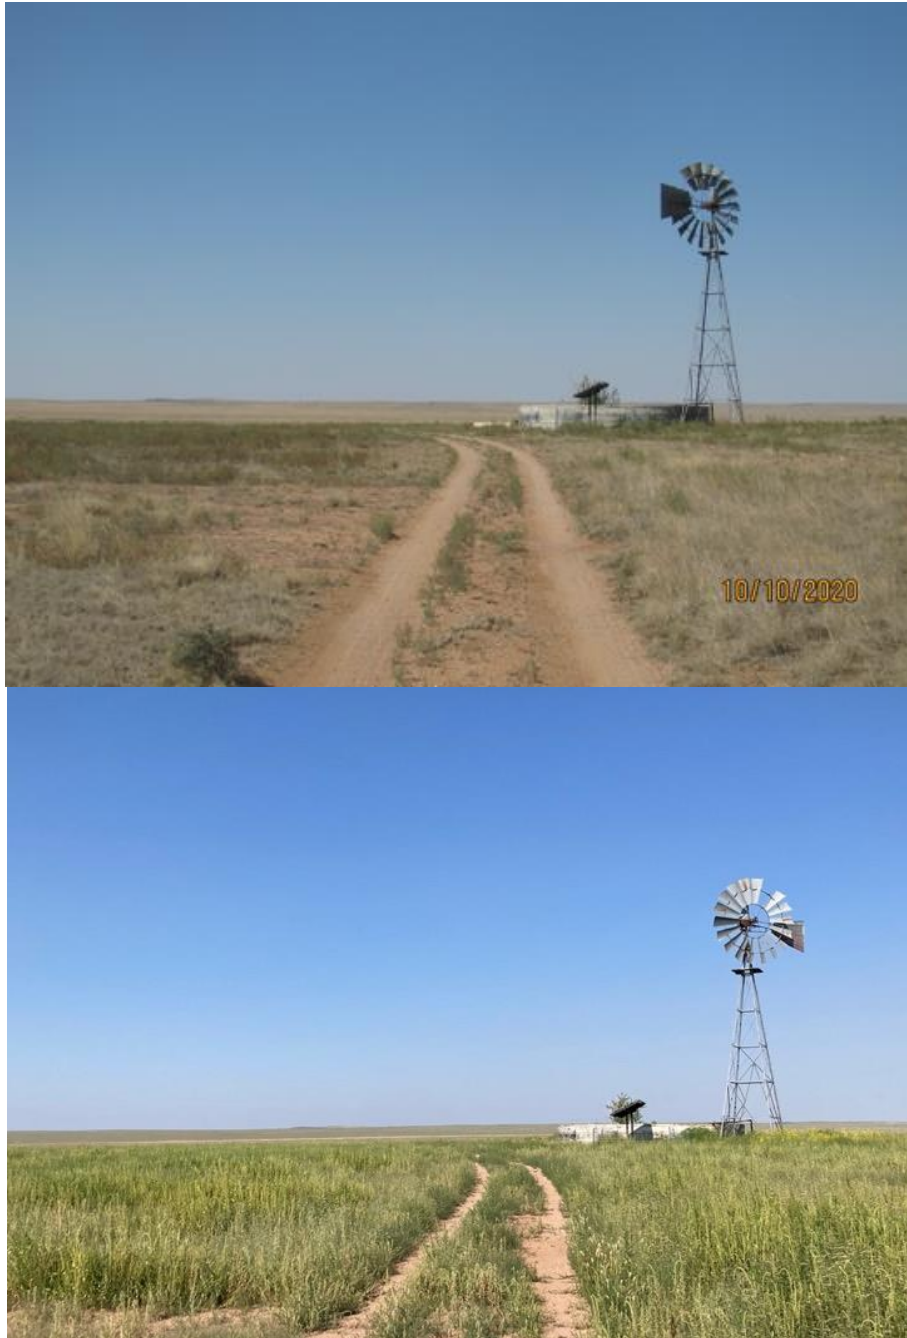
Figure 11. Mimms Unit Middle Windmill Photo Point photographed in October 2020 after a poor growing season (top) and again in September 2021 (bottom) after a more productive growing season). (Photo Credit – Philip Boyd)

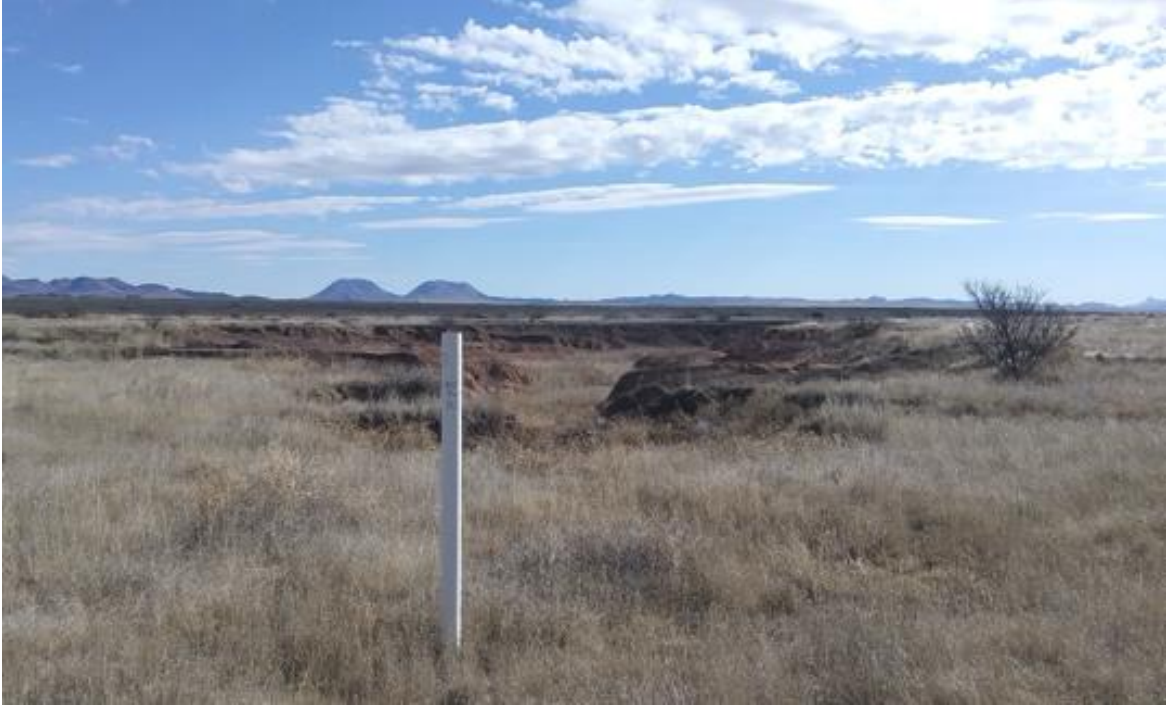
Figure 22. Facing east towards George Ranch monitoring point G3 (marked by white post in foreground) as it looked in 2020 with arroyo/gully in background. (photo credit – Philip Boyd)

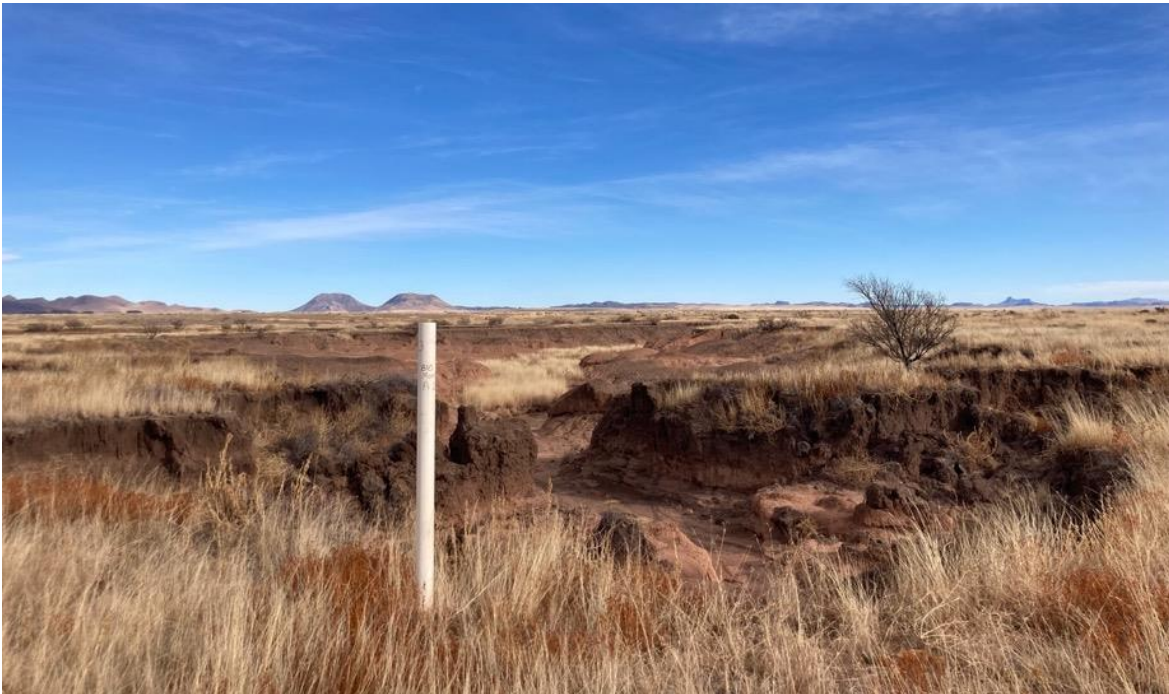
Figure 23. Facing east towards George Ranch monitoring point G3 (marked by white post in foreground) as it looked in 2021, with arroyo/gully in background, after significant soil loss in June 2021 floods. (photo credit – Philip Boyd)

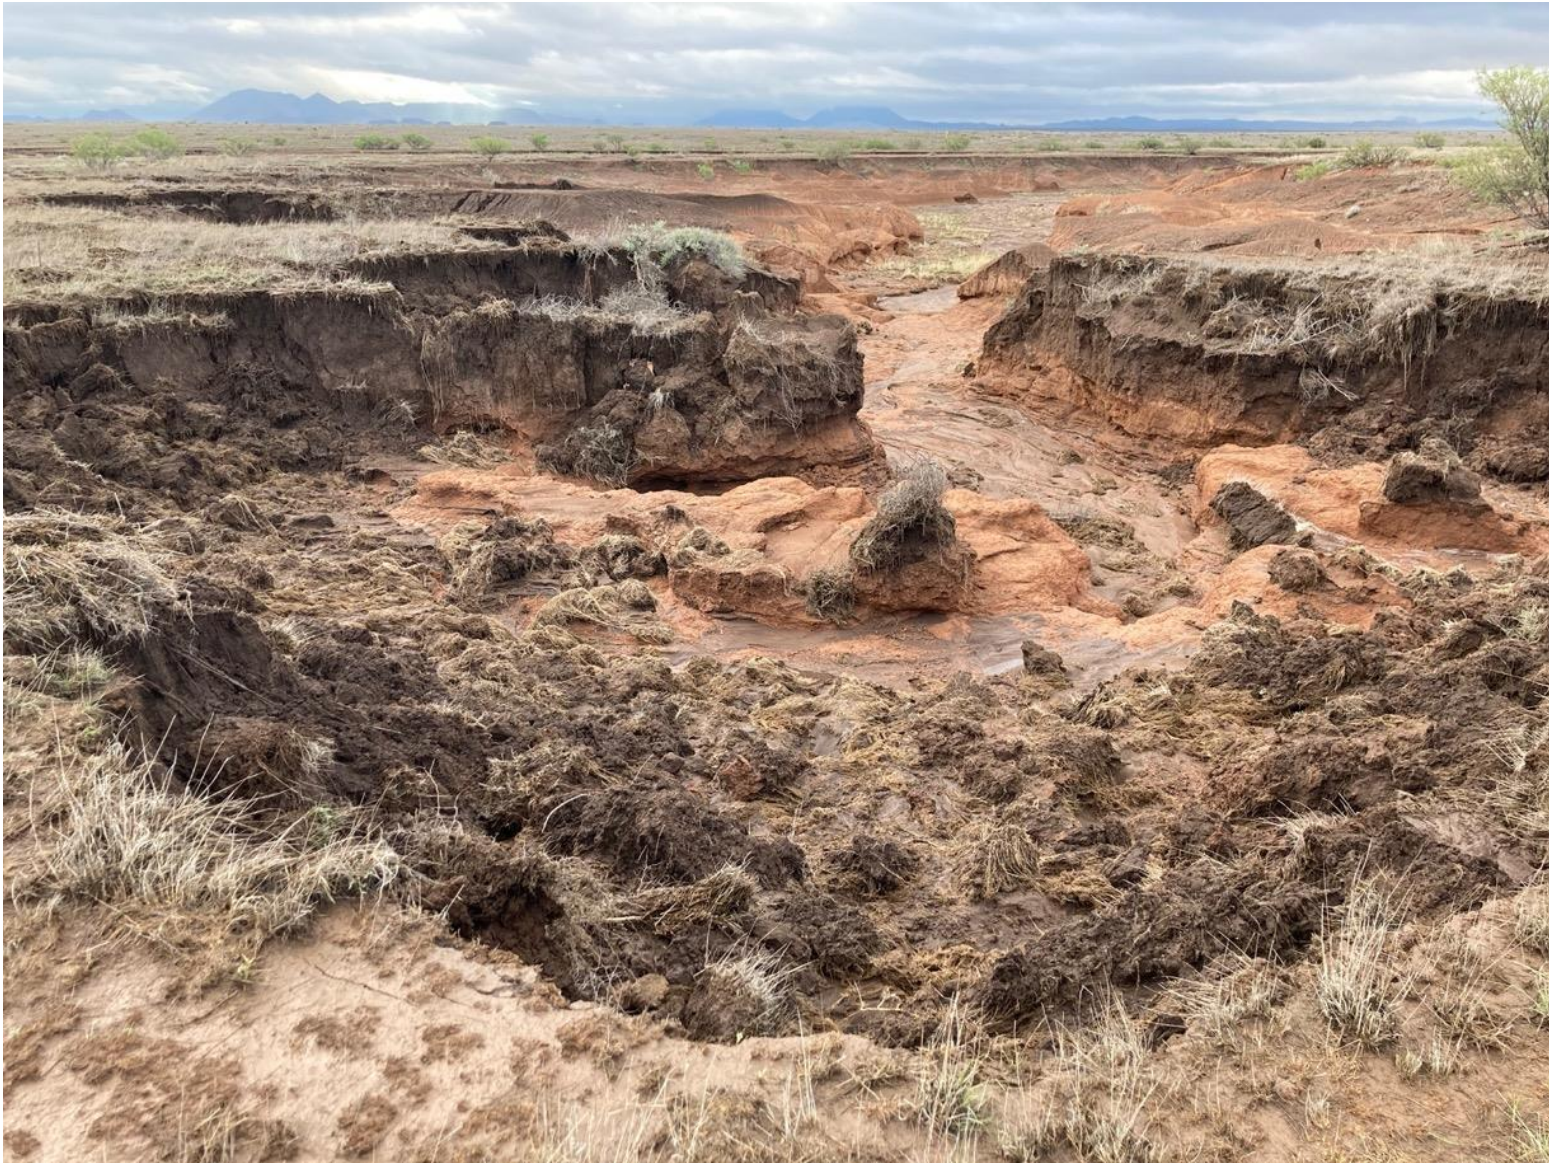
Figure 24. Erosion monitoring site showing evidence of bank collapse and soil loss soon after June 2021 floods (photo credit – Philip Boyd)

To monitor the rate of erosion of the cut banks along these arroyos, the Foundation set up bank erosion monitoring point east of biological monitoring point 2 in 2020. The bank erosion monitoring point is comprised of 8 rebar stakes. There were 4 stakes on the north side of the arroyo that are spaced 20 feet apart from one another, moving east to west. Directly south of each stake at 70 feet (840 inches) are 4 more rebar stakes along the southern edge of the arroyo. To monitor any bank erosion, a 100-foot tape measure is stretched south to north from the southern stakes. The distance along these transects from the rebar stakes to any bank edge is documented in a spreadsheet. Annual measurements are taken to document any changes in the size of the gully and rate of bank erosion. Several rebar stakes were lost in the flood events as banks toppled.

Monitoring efforts showed that roughly 111 linear feet of soil was lost along the erosion transects between 2020 and 2021 (*Table 3*). A large rainfall event in the Davis Mountains, upstream from the Mimms Unit and the Alamito Creek headwaters, made its way down to the

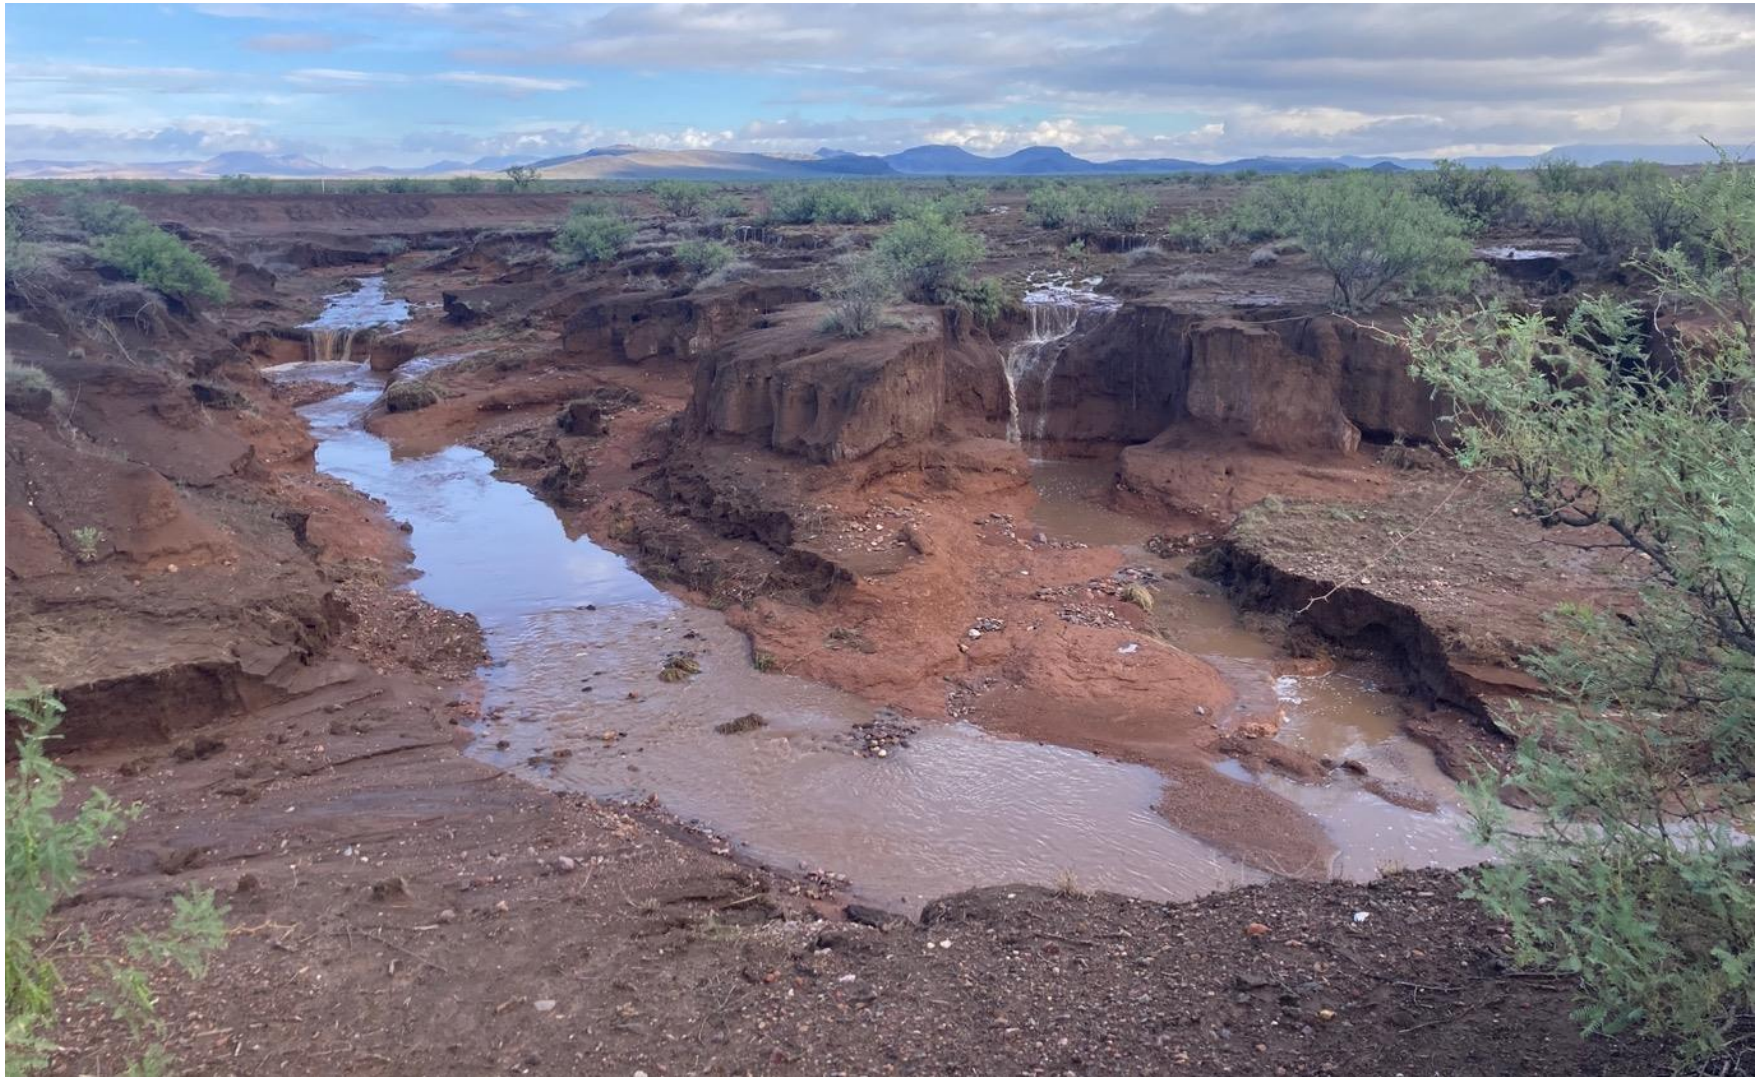
Figure 25. Just upstream from George erosion monitoring site, this photo shows water spilling around and over earth dam at knickpoints as floodwater works its way to the Alamito Creek bed below..

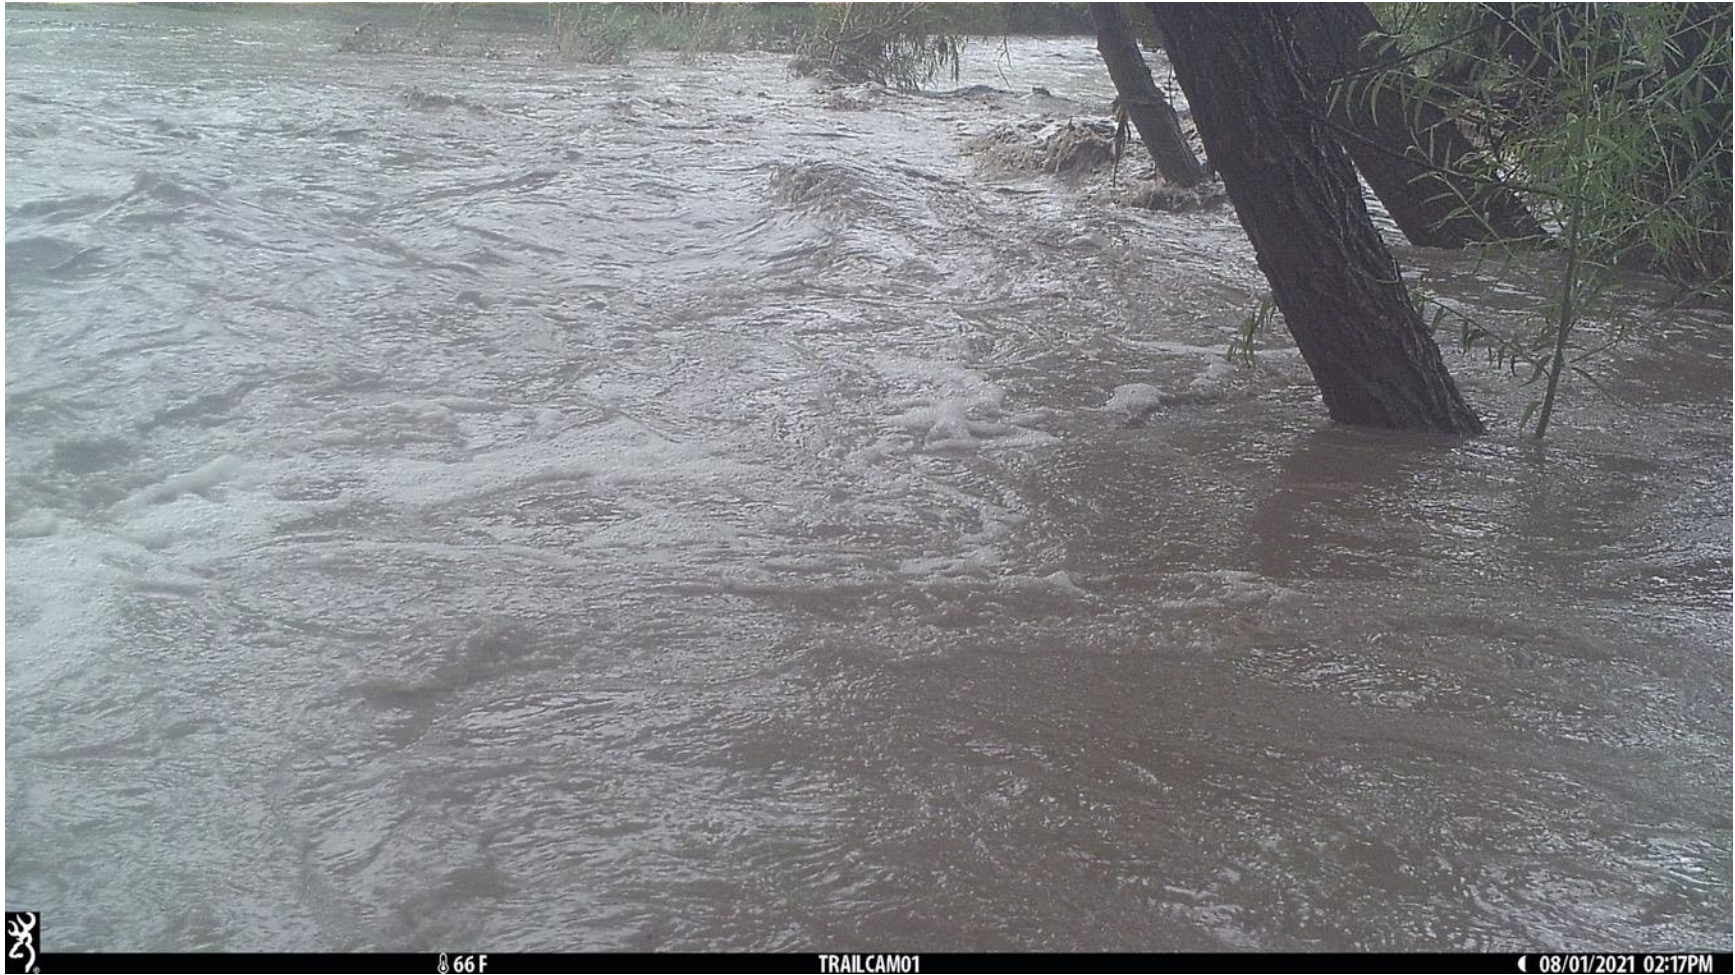
Figure 28. Several flood events took place in the creek channel at Alamito Creek Preserve in 2021. Many of these floods featured high-volumes of water inundating the channel for several hours and occasionally submerging the trail camera, which stands at about 7 feet above the creek bottom. This flood event in August 2021 filled the creek with rushing water for nearly 12 hours.

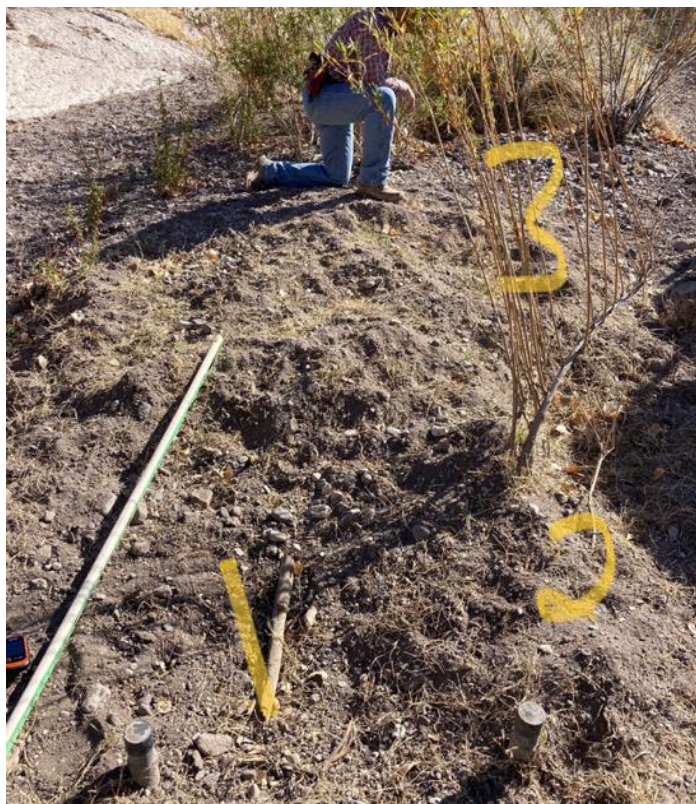
Figure 29. Wells in the Alamito Creek channel at the Alamito Creek Preserve. The wells are labeled in the image while facing downstream (Photo credit – Philip Boyd, June 2020)

Steel pipes driven into the bedrock in the Alamito Creek channel were marked (29°54'44.49"N, 104° 0'25.30"W) in summer 2020 (*Figure 27*). One pipe is topped with a cap which can be removed so that a measuring stick can be dropped into the pipe. A measuring stick can reach 49” into the ground before hitting a solid surface. The tape can be extracted and observed to identify how far the water surface is from the top of the well cap. In 2020 DWF set a goal to quarterly monitor of the water level in these wells, however, the increase of flood deposited gravel and sediment in the creek channel, destroying or burying the wells, making access difficult. The continued monitoring of these wells may be in question due to the conditions in which they are located. There were 2 monitoring efforts in 2021 (*Table 4*).

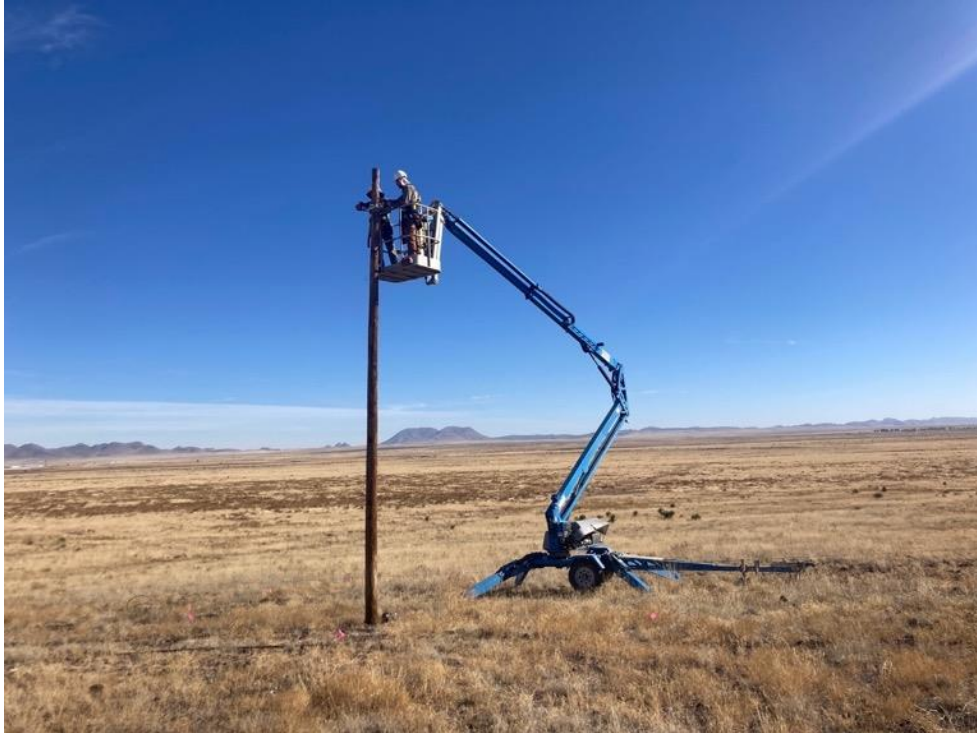
Figure 31. Bird Conservancy of the Rockies technicians prepping an out-of-service utility pole to be repurposed as a Motus tracking station on the Mimms Unit, December, 2021 (photo credit – Philip Boyd)

The Motus station was installed on an out-of-service utility pole that had been on the Mimms Unit and unused for the duration of the Foundation's ownership of the property. Technicians brought a mobile installation lab and rented a lift to install the devices on this repurposed this pole. The station is solar powered, grounded, and equipped with a regulation system to reduce the impact of lightning strikes.

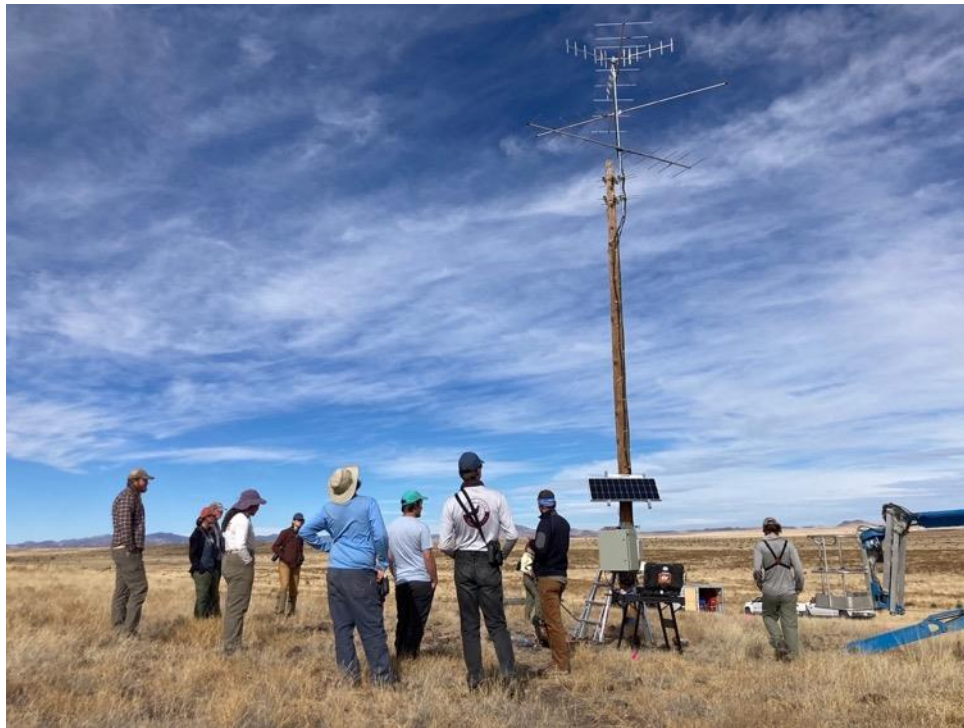
Figure 32. Bird Conservancy of the Rockies field technicians viewing the completed Motus tracking station, December, 2021 (photo credit – Philip Boyd)

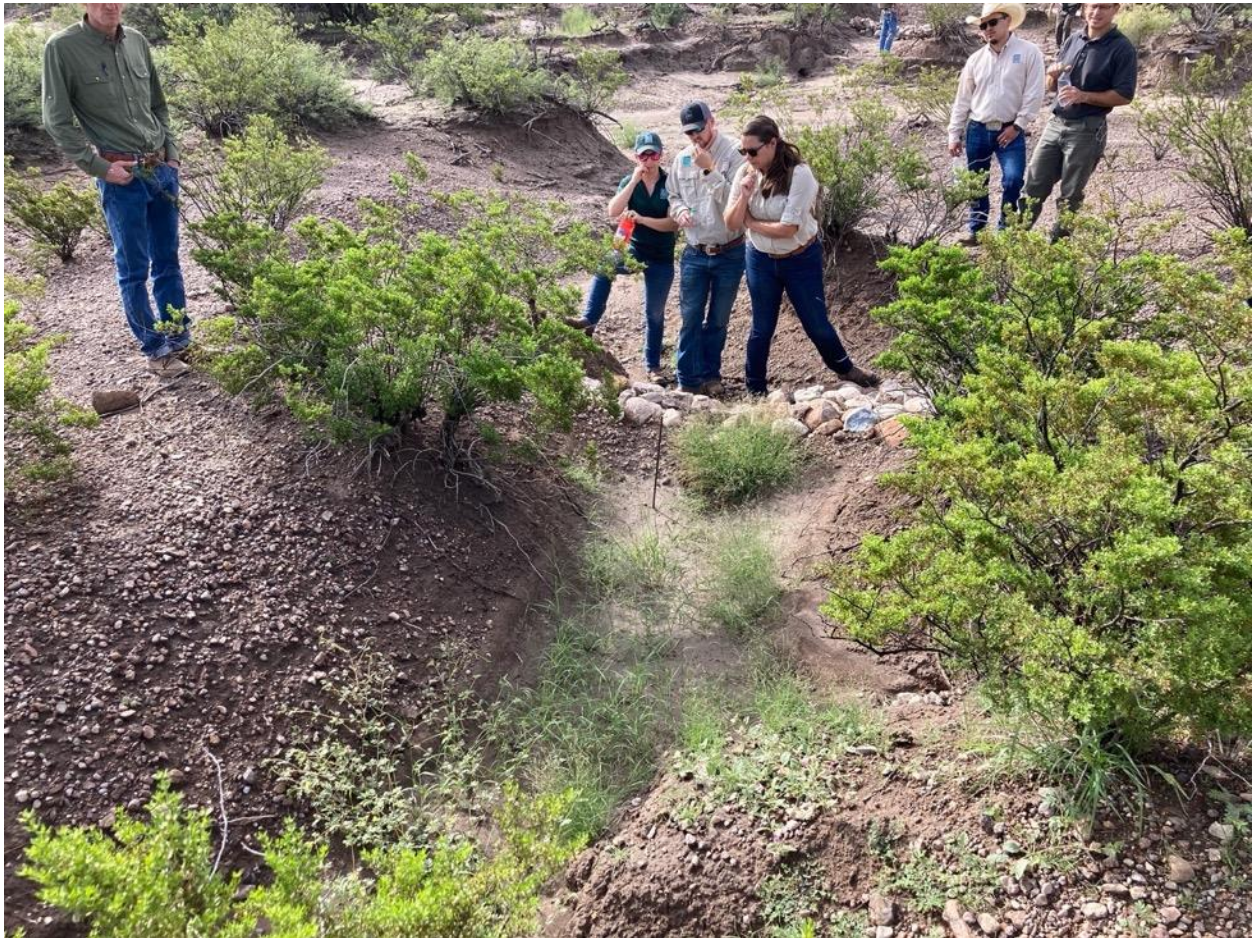
Figure 33. Texas Parks and Wildlife Department biologists and local land managers stand downstream from a leaky rock dam, installed in an eroded tributary channel April 2021, and view vegetation growing in caught sediment on the upstream side of the structure between April and August 2021.

involves driving wooden posts into the creek bed and then weaving brushy material between the posts. These structures are intended to work similarly to leaky rock dams in that they slow the flow of water, help spread water out, and keep creek systems hydrated for longer periods of time. Within the conservation community, riparian zones in the Southwest are areas of concern. Historically, vegetation was removed, and these systems were compromised once the hydrology shifted. These zones provide habitat for wildlife, can support planned cattle grazing operations, and serve as recharge zones for groundwater as precipitation events make their way downstream. The Foundation will continue to explore, evaluate, and experiment with potential restoration techniques that utilize materials that can be processed by these systems while also increasing functionality.

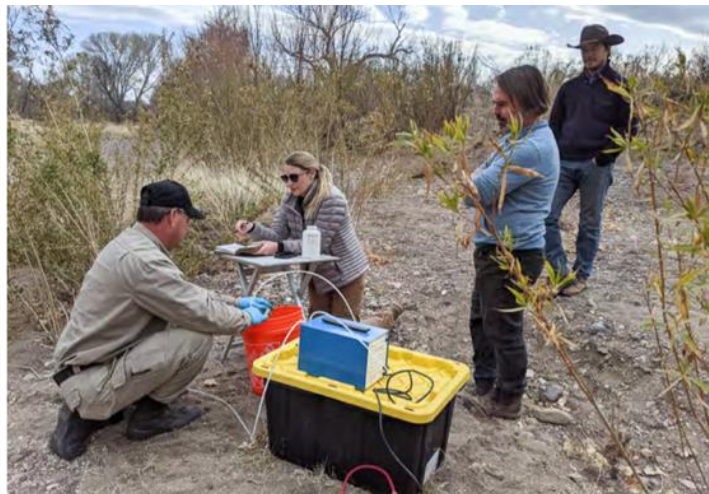
Figure 35. Straub Corporation sampling wells in Alamito Creek channel that were left over from USFWS project in 2014, which are mentioned earlier in the Groundwater Monitoring portion of this report. (Carolyn McCartney, February 2021)

Geochemical analysis suggested that the 2 wells sampled on the Dixon property, as well as the springs or seeps within the creek bed, were most likely drawing from similar groundwater sources, while wells on neighboring properties were considered deep wells that drew from other sources. The Dixon wells were shallow wells. These wells and Dixon springs are most likely associated with recharge from precipitation falling on the upper reaches of Alamito Creek and its drainages. The deeper wells sampled in the area around Alamito Creek Preserve seem to also be associated with precipitation recharge, but from a deeper zone, indicating that this precipitation fell at a cooler time in the past. The Straub Corporation made a disclaimer that these results are inconclusive and are based on a relatively small sample size. This research is only meant to advance the scientific understanding of the groundwater in the region.
