Dixon Water Foundation Annual Report - 2022

2022 – ANNUAL REPORT

This report summarizes the efforts taken by Dixon Water Foundation to achieve the goals of their mission in the year 2022.

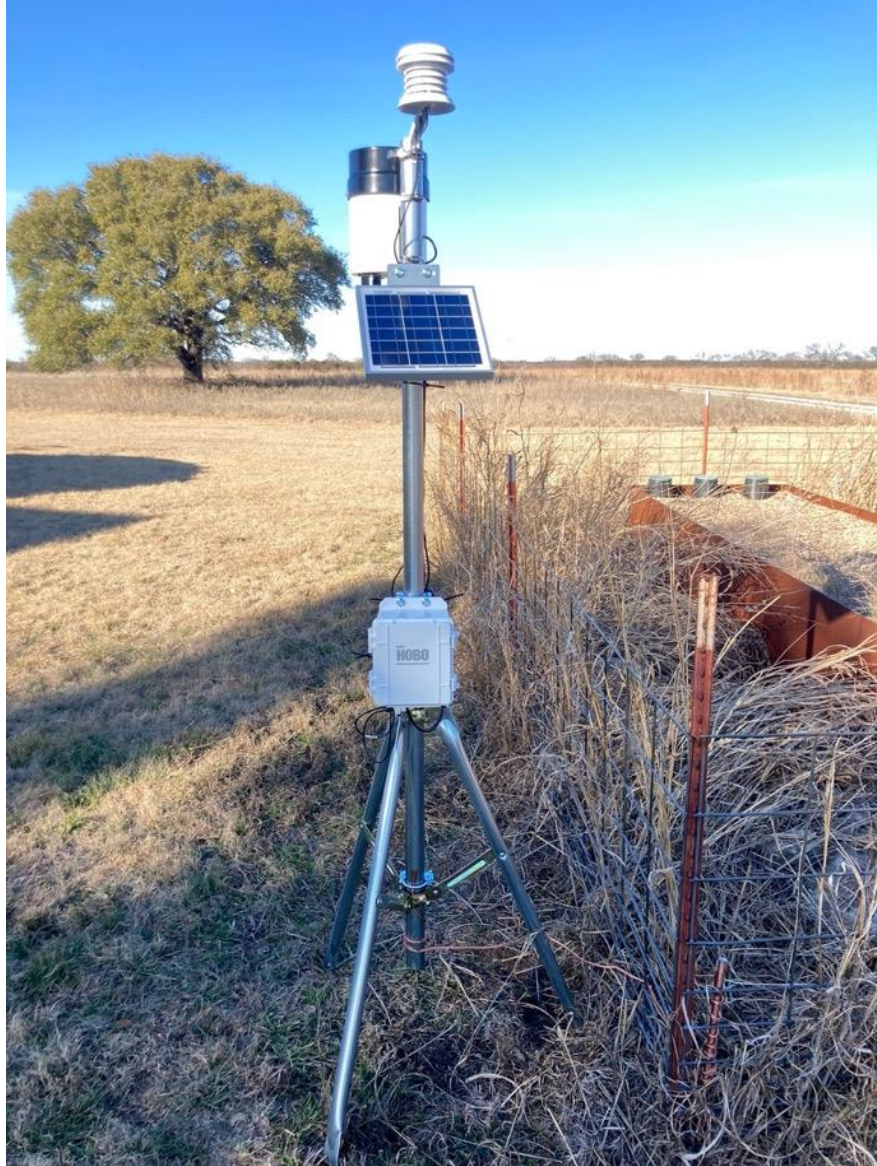
Figure 4. Weather station installed at the Josey Pavilion in January 2022 (Photo by Philip Boyd).

Precipitation at the Leo was measured with an analog gauge at the ranch office which is documented on a paper grazing chart until January 2022 when a HOBOLink weather station was installed at the Josey Pavilion (*Figure 4*).

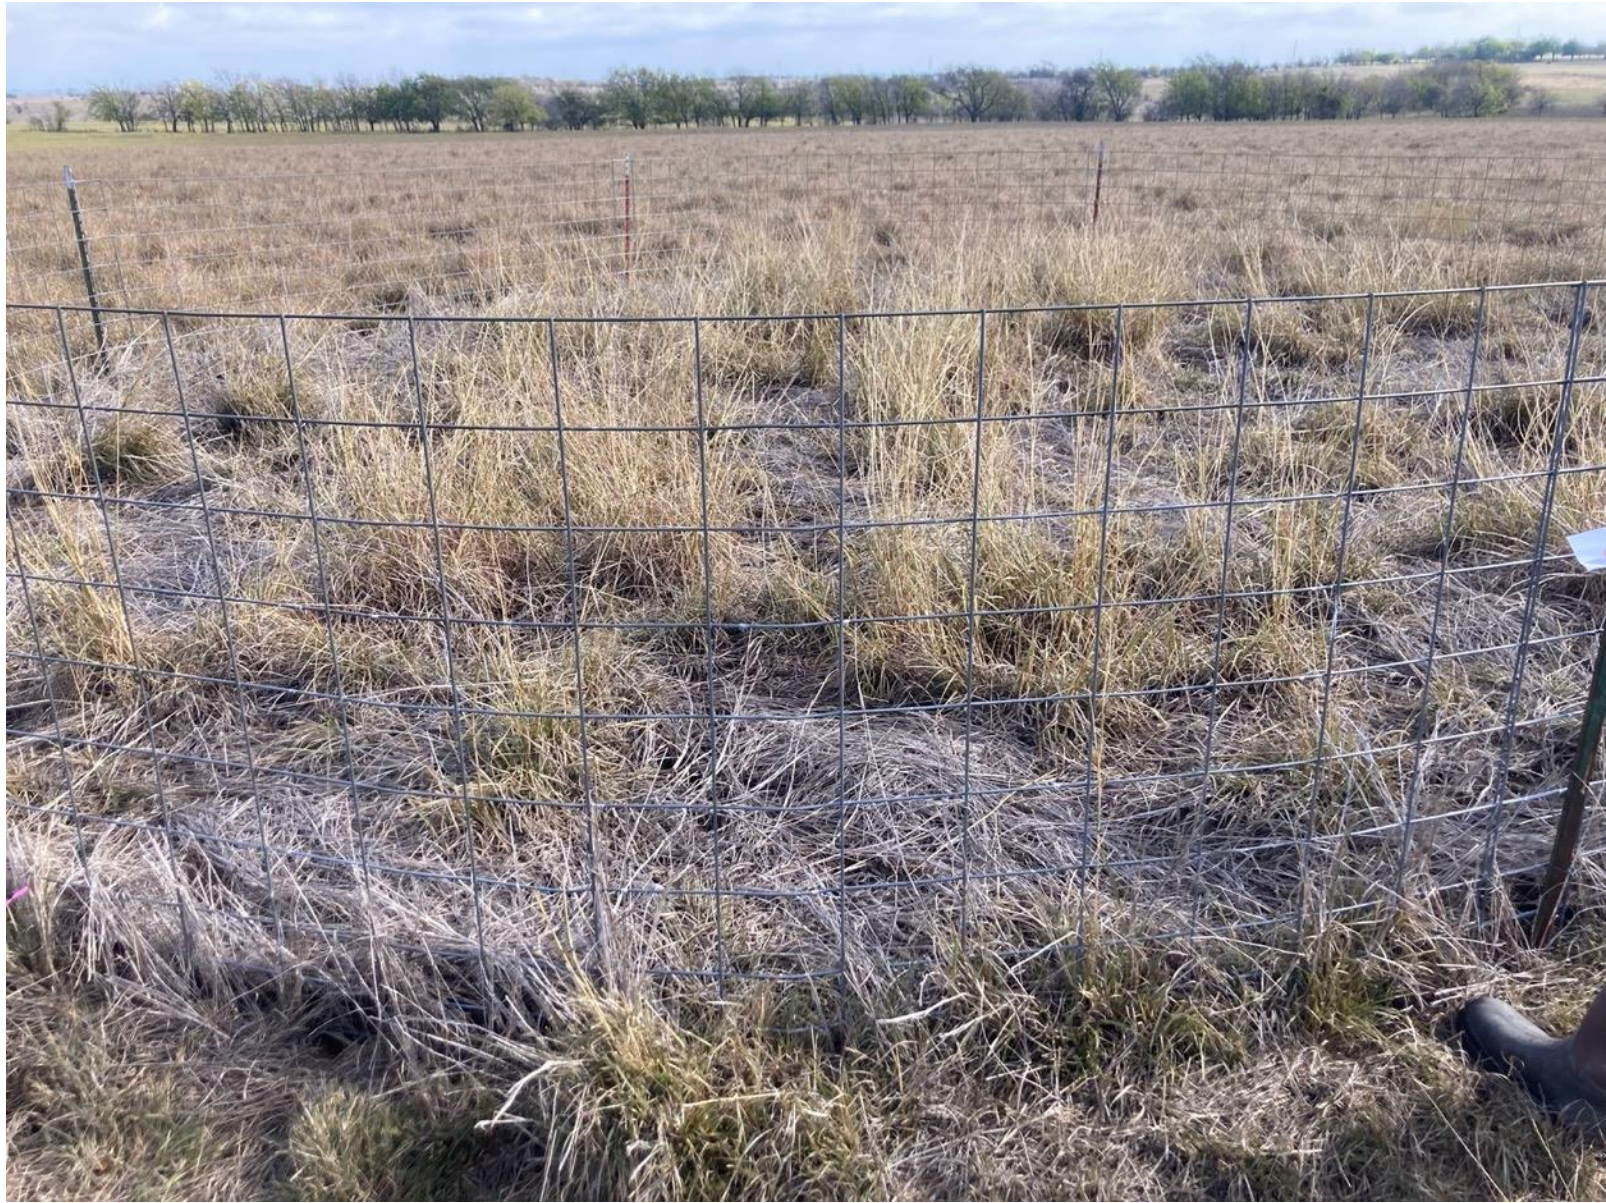
Figure 9. Dying grasses within the un-grazed and undisturbed exclosures on the Heard Property 2022. (Photo by Philip Boyd)

The Foundation ranches feature several areas that have excluded any large-animal grazing pressure from the time purchase of the properties. These sites are meant to serve as points to monitor and observe any differences between the portions of the ranch included in the multi-paddock grazing regime and those excluded from it. While monitoring on the Heard in 2022, one of these exclosures was photographed and illustrates a phenomenon that can happen when grasses are left undisturbed. Left undisturbed, grasses can thrive to the point of growing decadent and dense enough to shade neighboring plants out. This image captures the contrast between dying grasses within the exclosure against active plants outside of the exclosure (Figure 9).

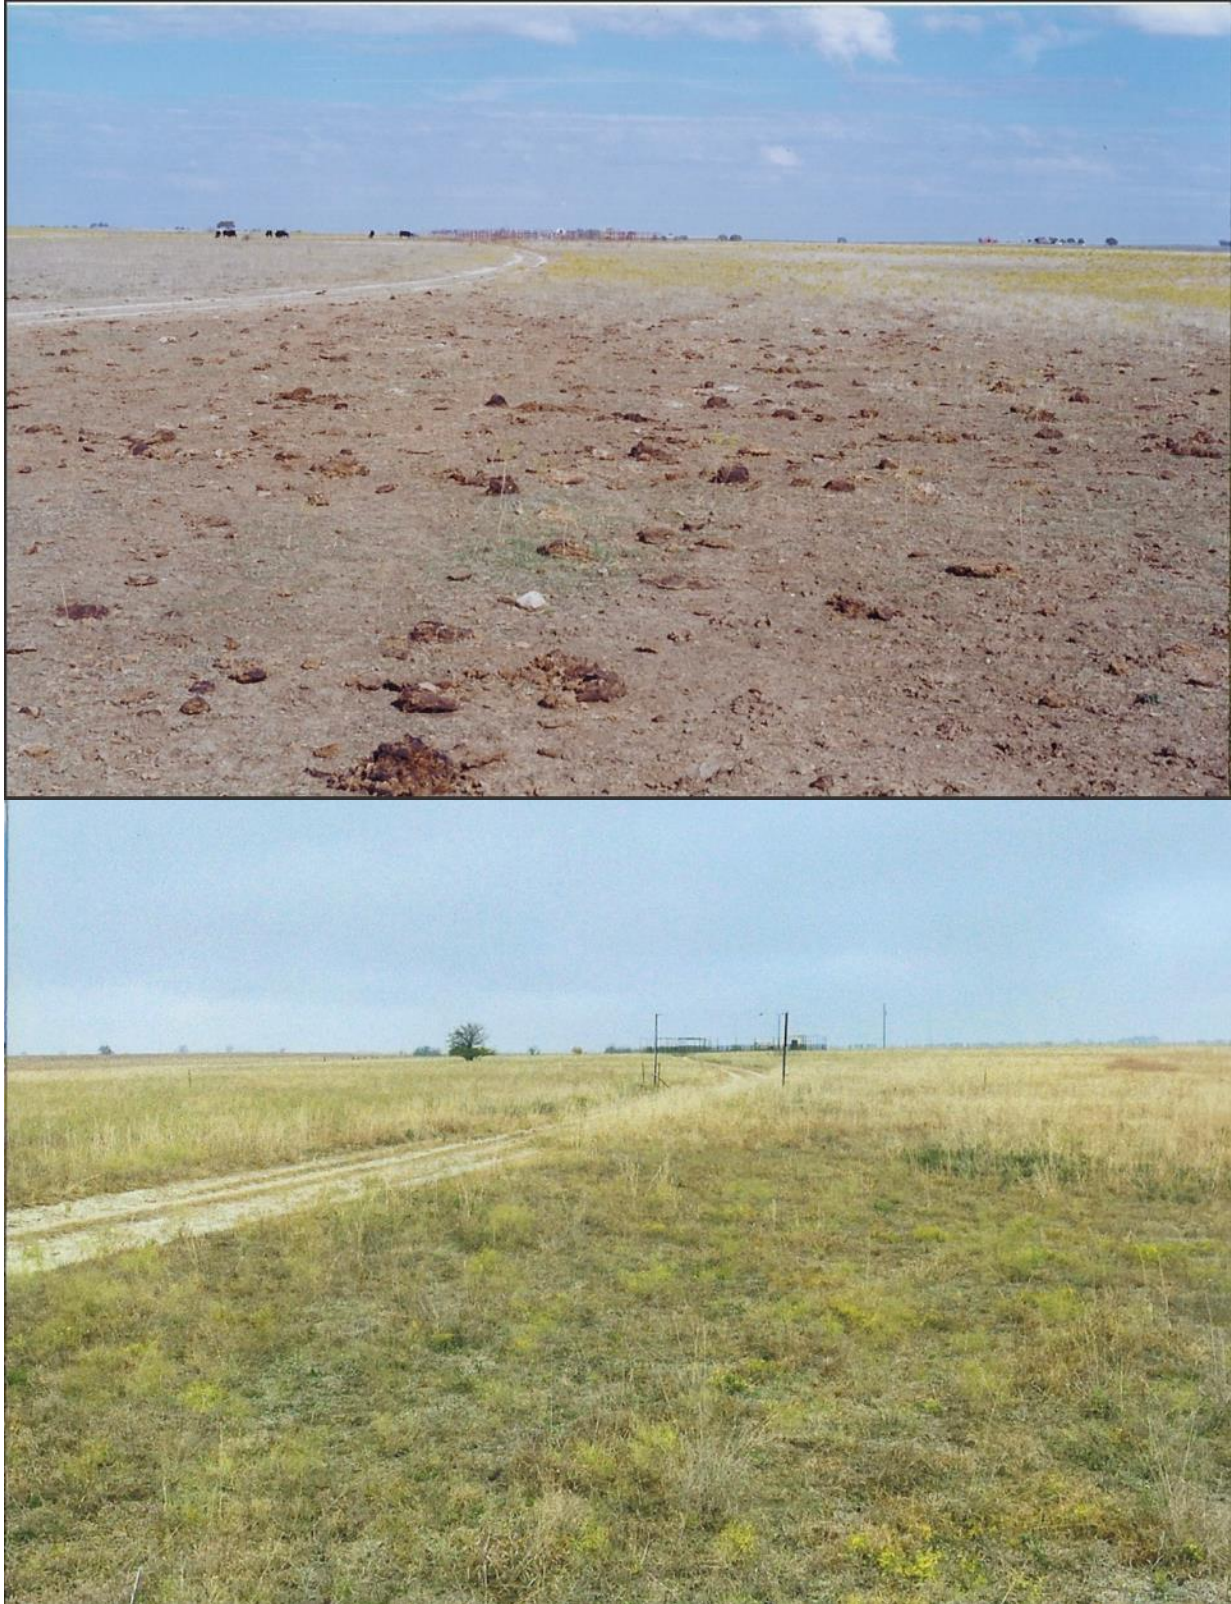
Figure 11. Comparison photos of the Pittman Unit at the time of purchase, under continuous grazing (1999, top) and after more than a decade of adaptive multi-paddock grazing management (2020, bottom) (Photos by Melissa Bookhout)

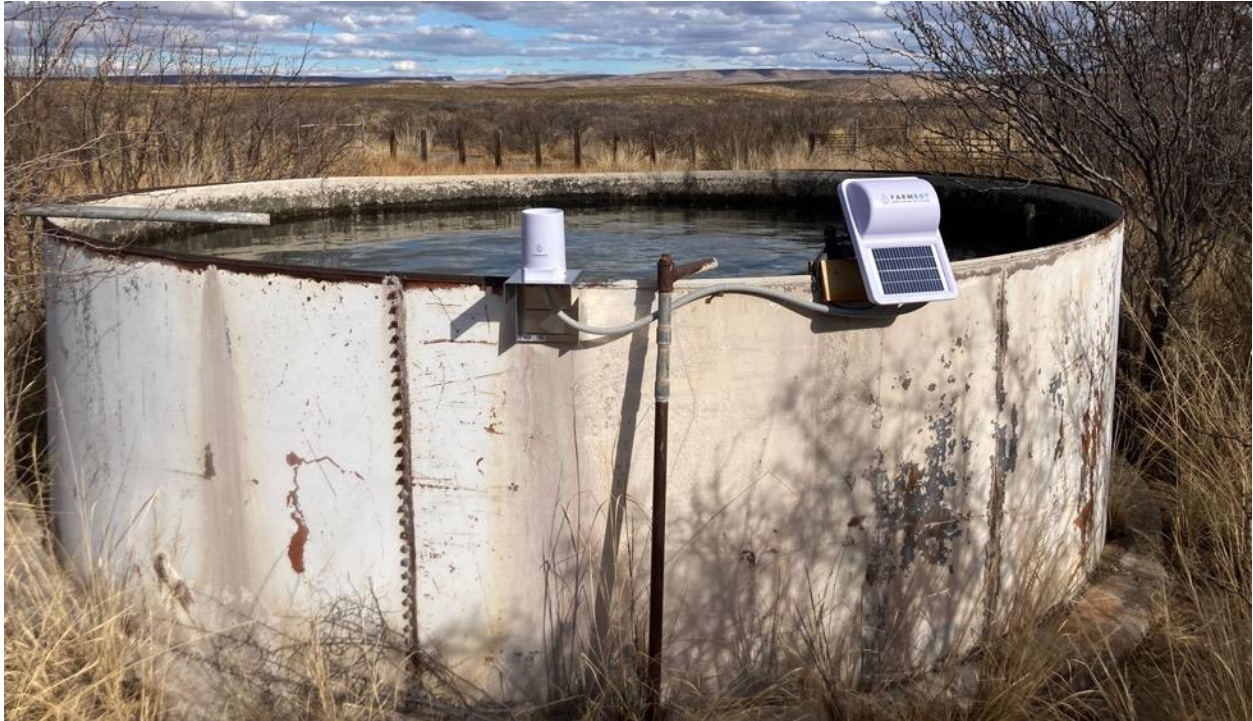
Figure 15. RanchBot rain gauge (left) and solar-powered tank sensor (right) installed at the Matanoso Pens of Alamito Creek Preserve, spring 2022 (Photo by Philip Boyd)

A HOBOLink weather station had been installed at the Preserve and was replaced by a Ranch Bot tank sensor and rain gauge in spring of 2022 (*Figure 15*). The rain gauges collected a total

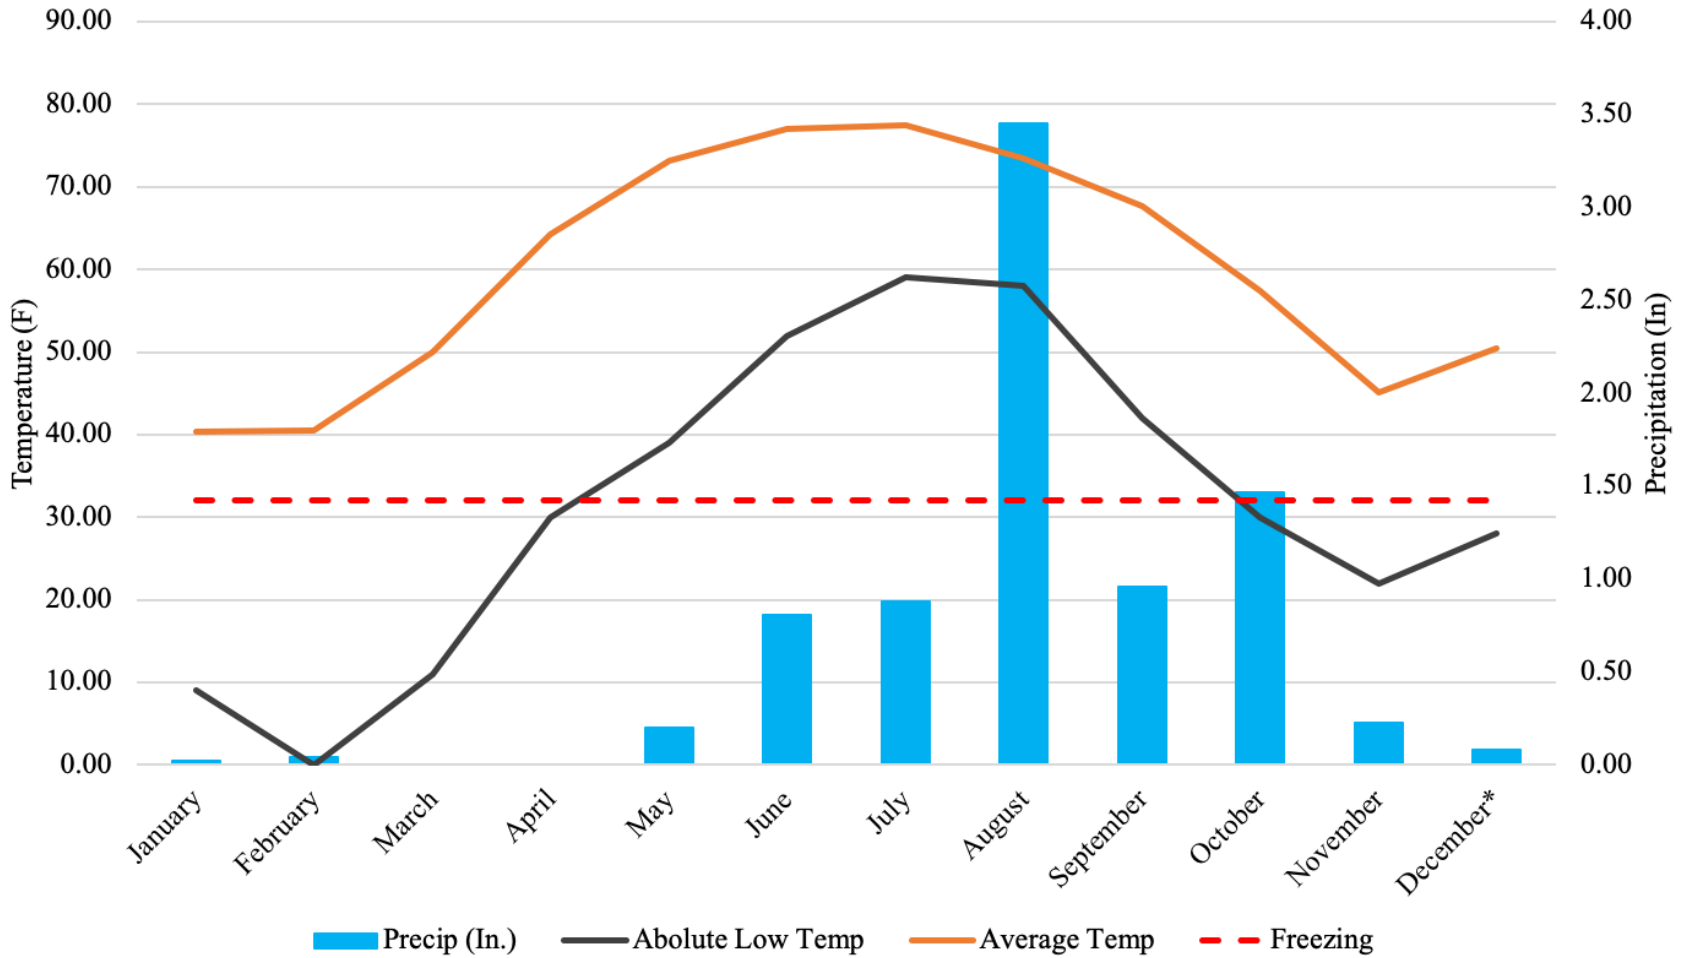
Figure 20. Weather summary for Mimms Unit, Marfa, Texas, 2022. Precipitation totals are show in blue bars with inch measurements on right axis, average temperatures are shown on the orange line with degrees Fahrenheit on left axis. Absolute temperature is marked in black with the freeze threshold marked in red.

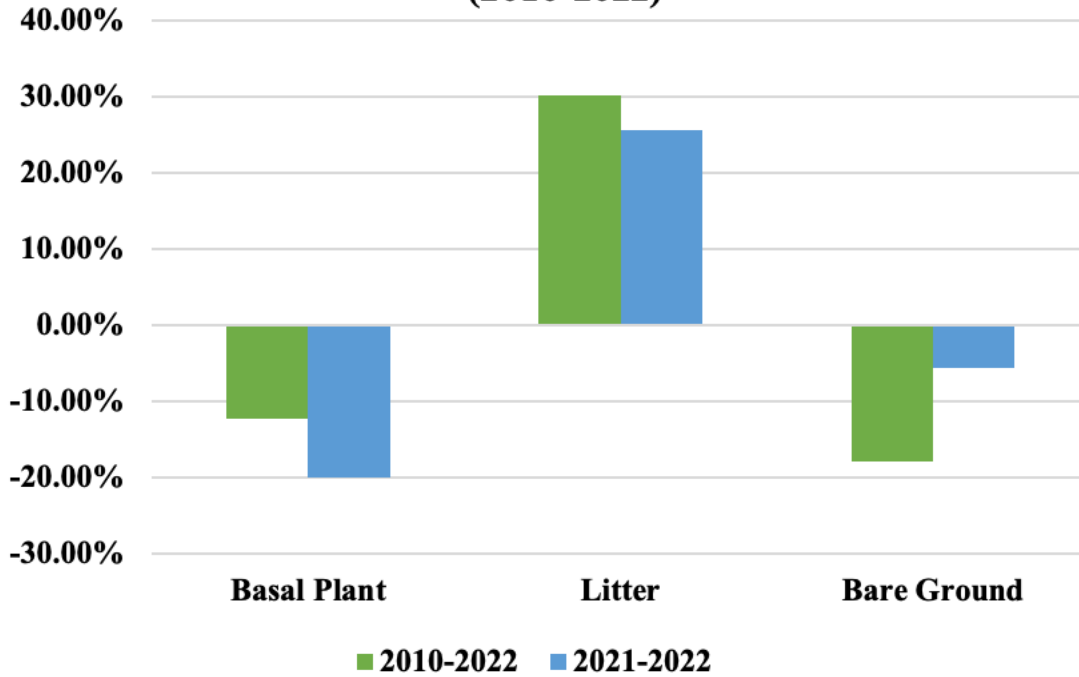
Figure 22. Percent change in ground cover types between 2010-2022 (green) and 2020-2022 (blue).

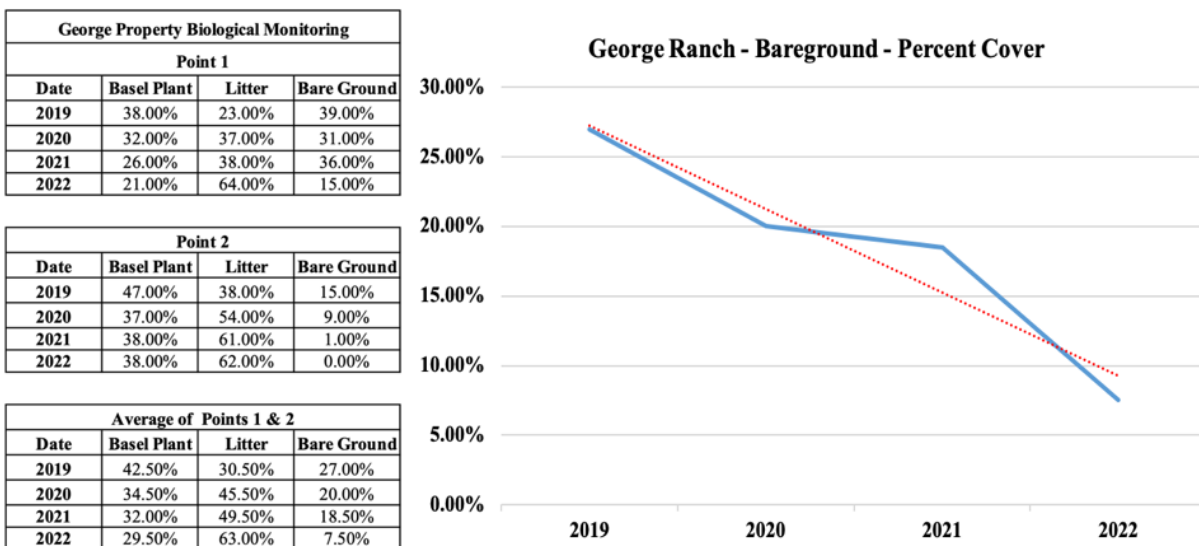
Table 2, Figure 26. Percent of each cover type for monitoring point G2 on the George Property from the initial monitoring effort in 2019 until 2022.

George Property – The George Property was purchased by the Foundation in 2019. The current year marks the 4th monitoring effort on the George. In 2020, 3 points were monitored, but the Foundation returned to monitoring 2 points in 2021 for the sake of efficiency in the monitoring program. When reducing the number of points on the George to 2, staff can complete the monitoring process for the Mimms and George in 1 day. In 2022, staff monitored the same two points as 2019 and 2021. With a sample size of only 4 years, it is difficult to determine any trends. An average decrease in bare ground has of -19.5% has been documented across the two monitoring points from 2019-2022 (*Table 2, Figure 26*).

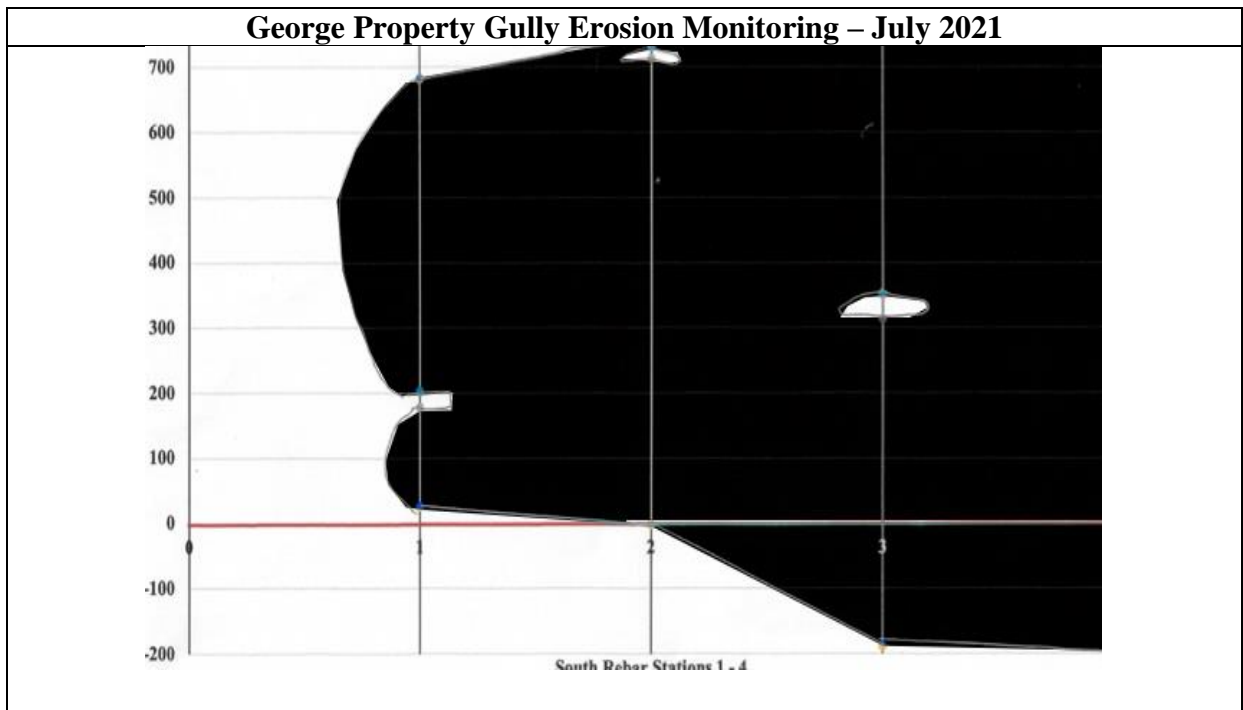
Figure 28. Estimation of George Gully shape, bird’s eye view, June 2020 based on erosion station measurements. The white spaces represent the upper level grasslands, while the black spaces represent collapsed areas.

Monitoring efforts in 2022 recorded similar dimensions to the gully as were recorded in 2021 (*Figure 28 and Figure 29*). Most of the soil loss appears to have been minimal and contained to the loss of some remnants of previously-collapse banks (*Figure 30 and Figure 31*). Staff will continue annual monitoring efforts and will discuss any potential mitigation techniques. The Foundation did fence the riparian corridor in 2021, which should help reduce some erosion caused by water gathering in cattle trails leading into the creek bed.

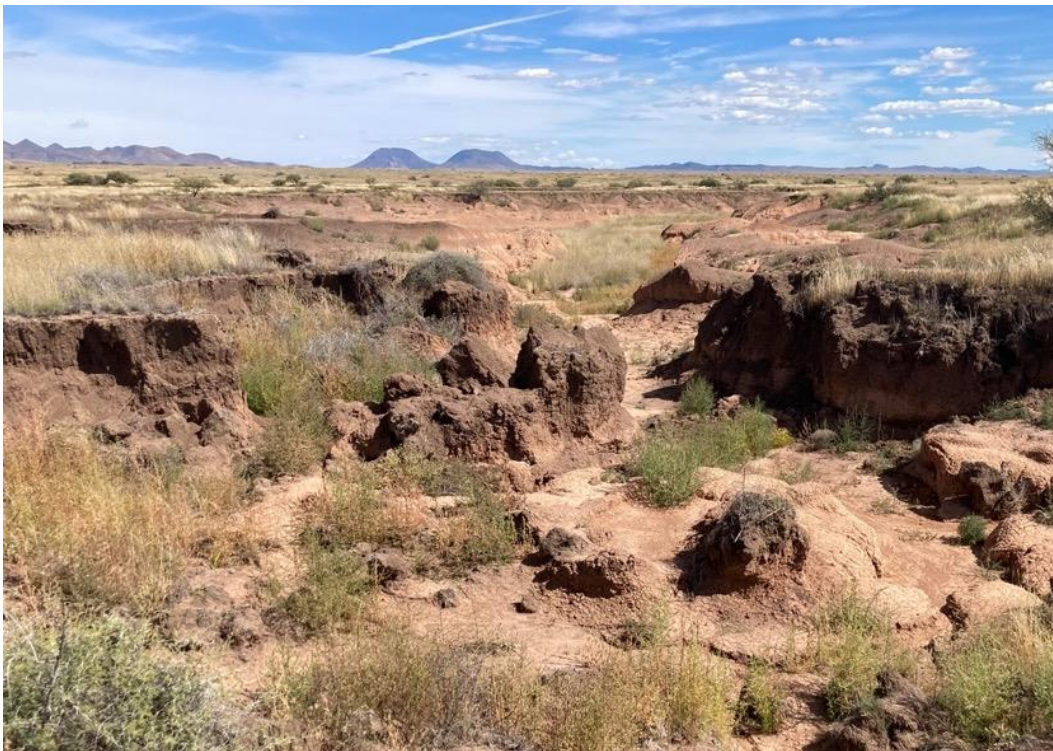
Figure 30. Facing east towards George Ranch arroyo/gully as it looked in October, 2021. Photo by Philip Boyd)

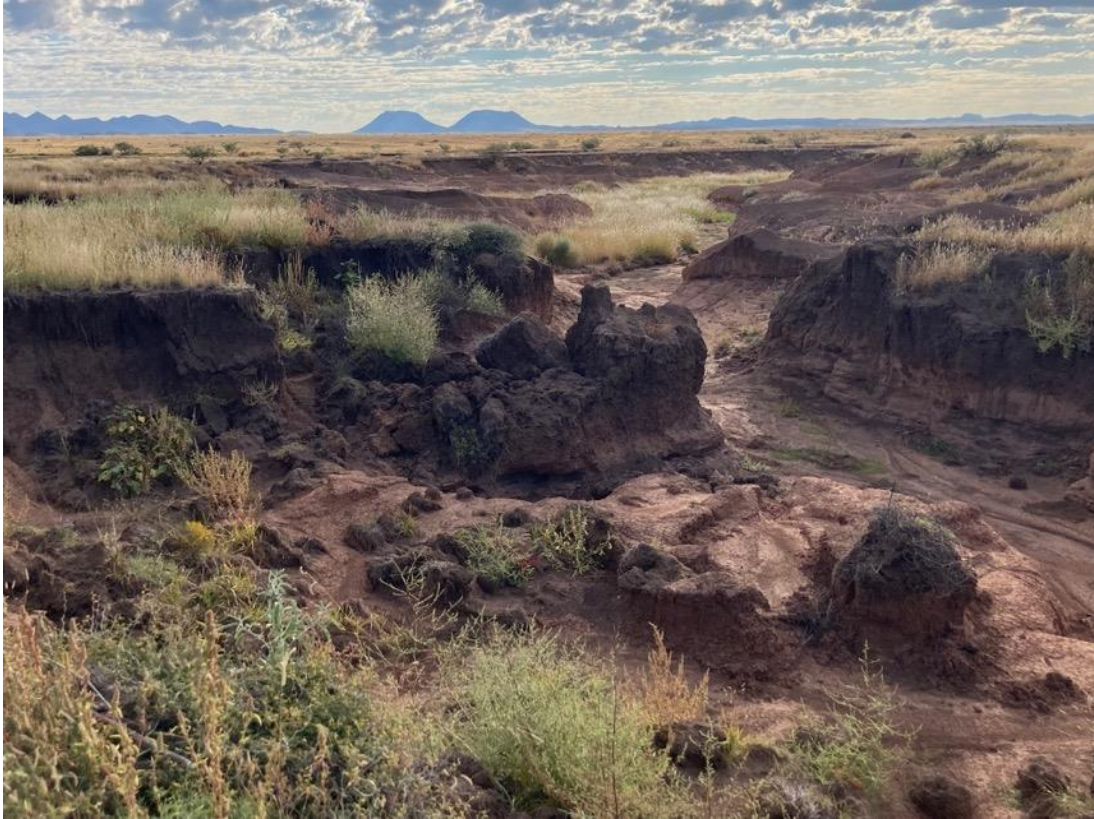
*Figure 31. Facing east towards George Ranch arroyo/gully as it looked in October, 2022.
Photo by Philip Boyd)*

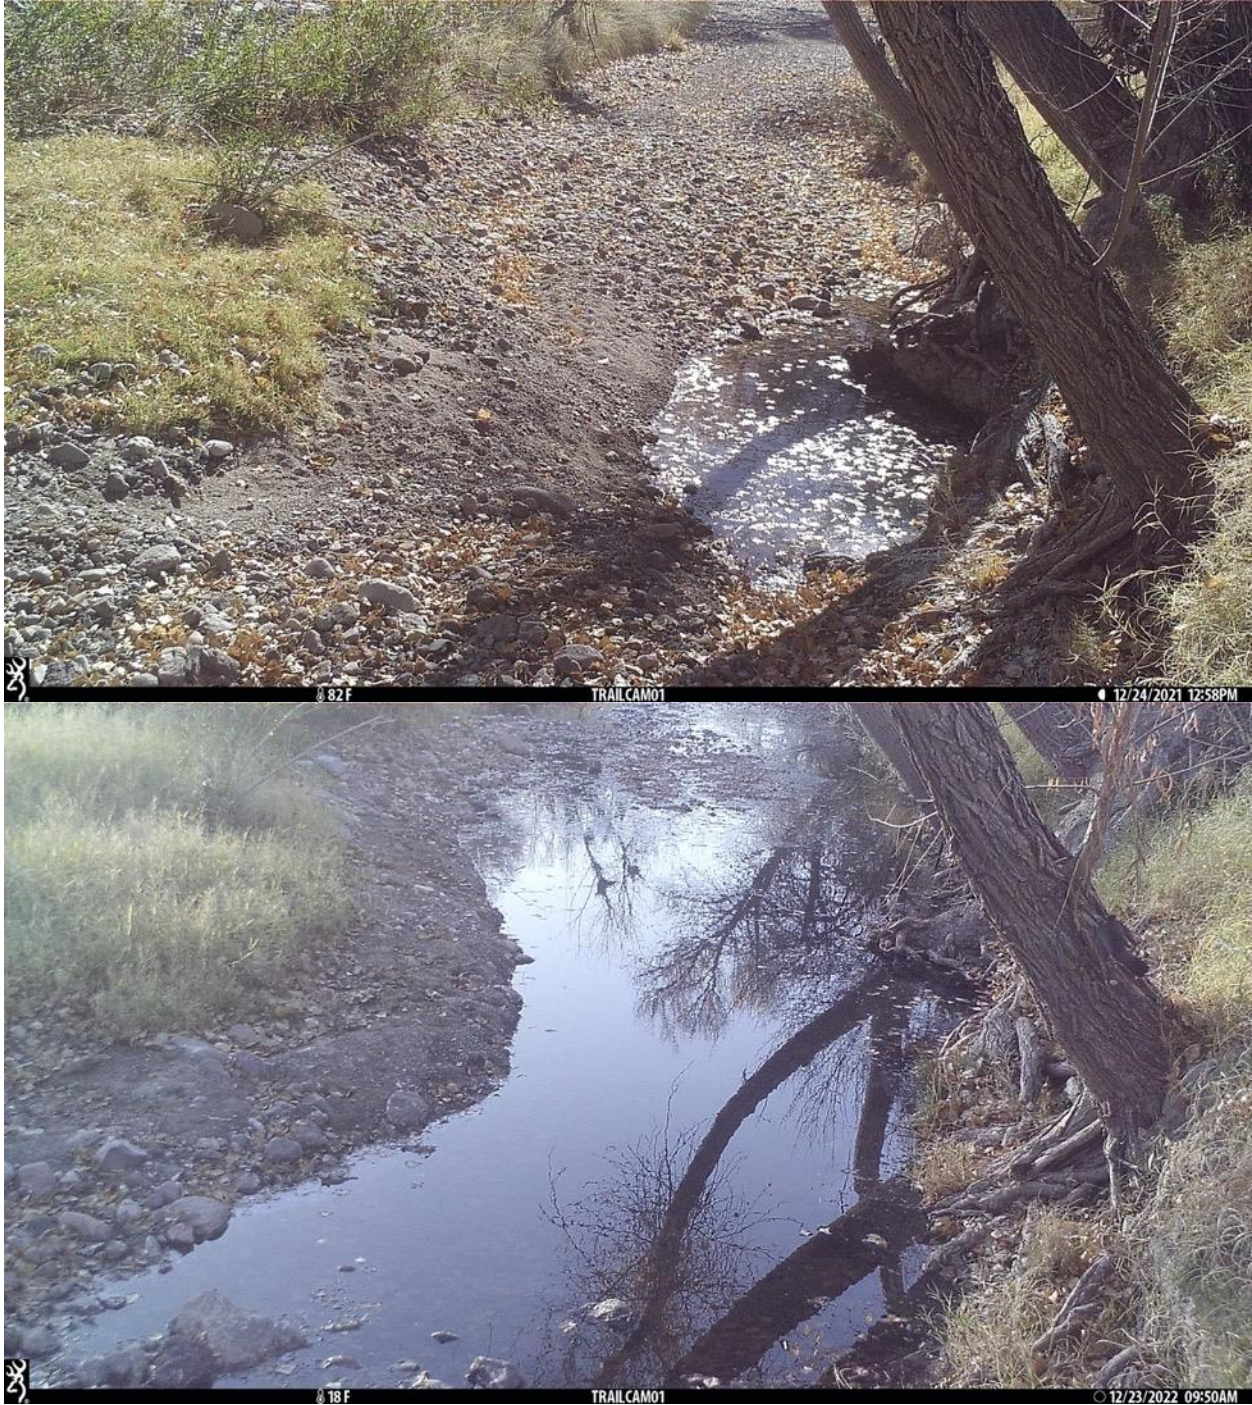
Figure 34. Comparison photos showing the contrast in amount of consistent water in the creek, late December 2021 (top) and late December 2022 (bottom) on the Foundation's Alamito Creek Preserve downstream-facing trail camera.

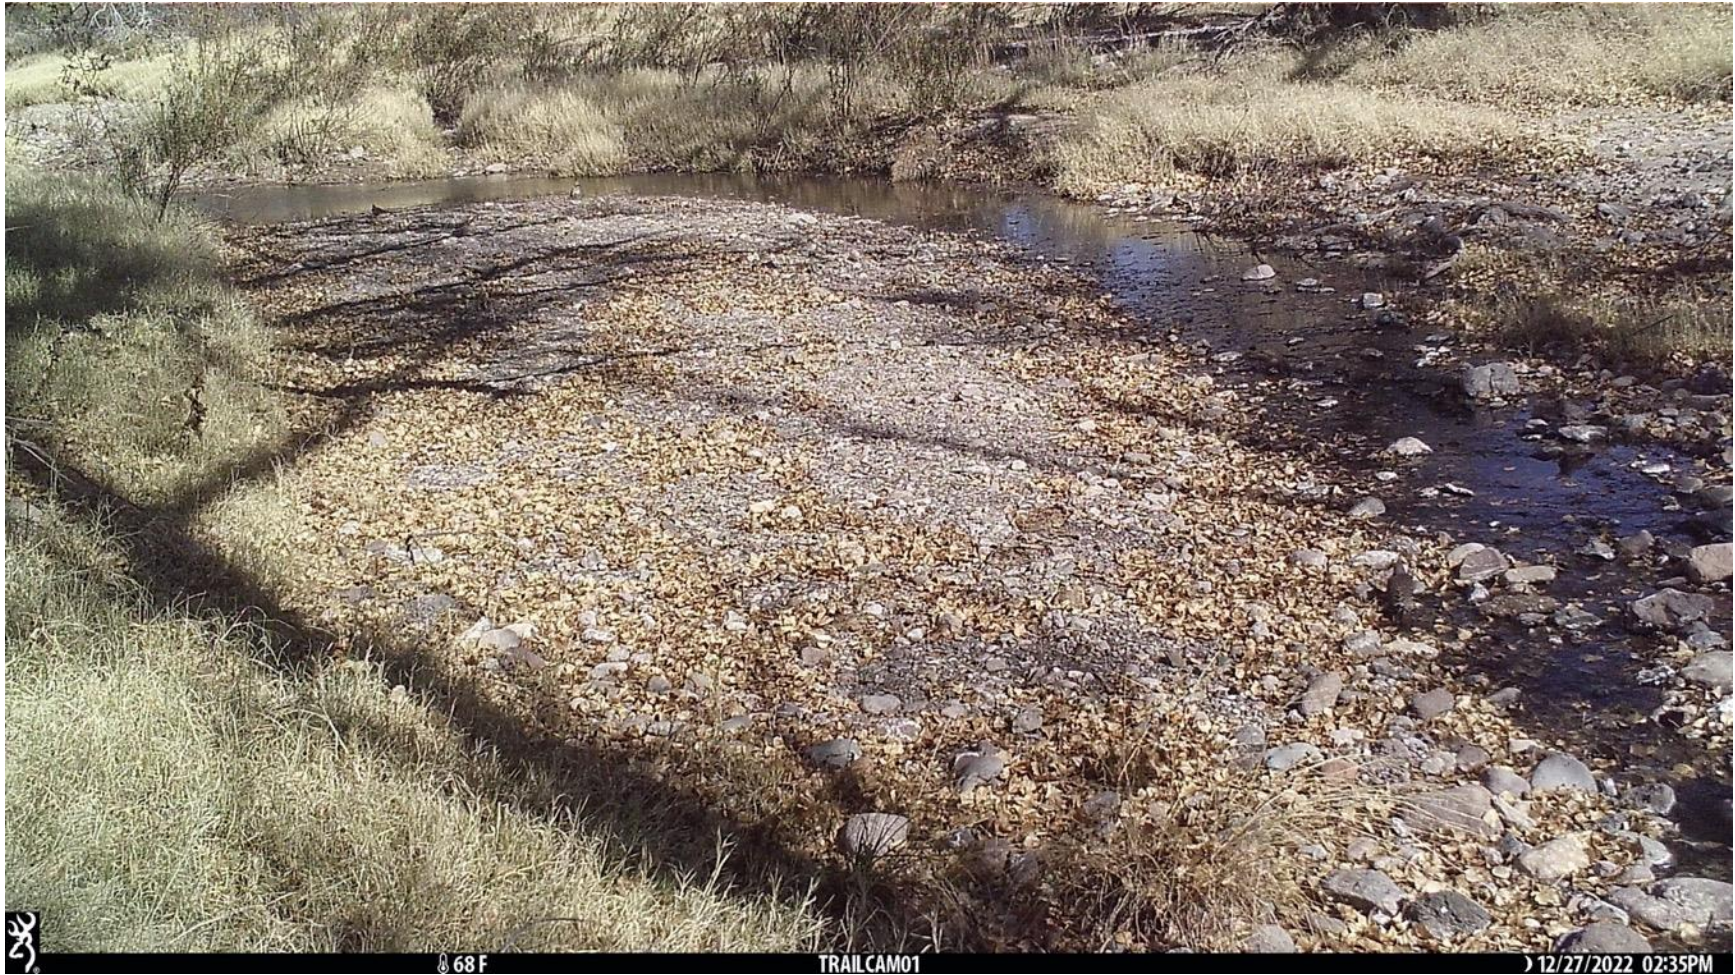
Figure 35. Upstream-facing trail camera shows overland flow connecting upstream pools to downstream pool. Water has been consistently trickling along this stretch of creek since late summer 2022.

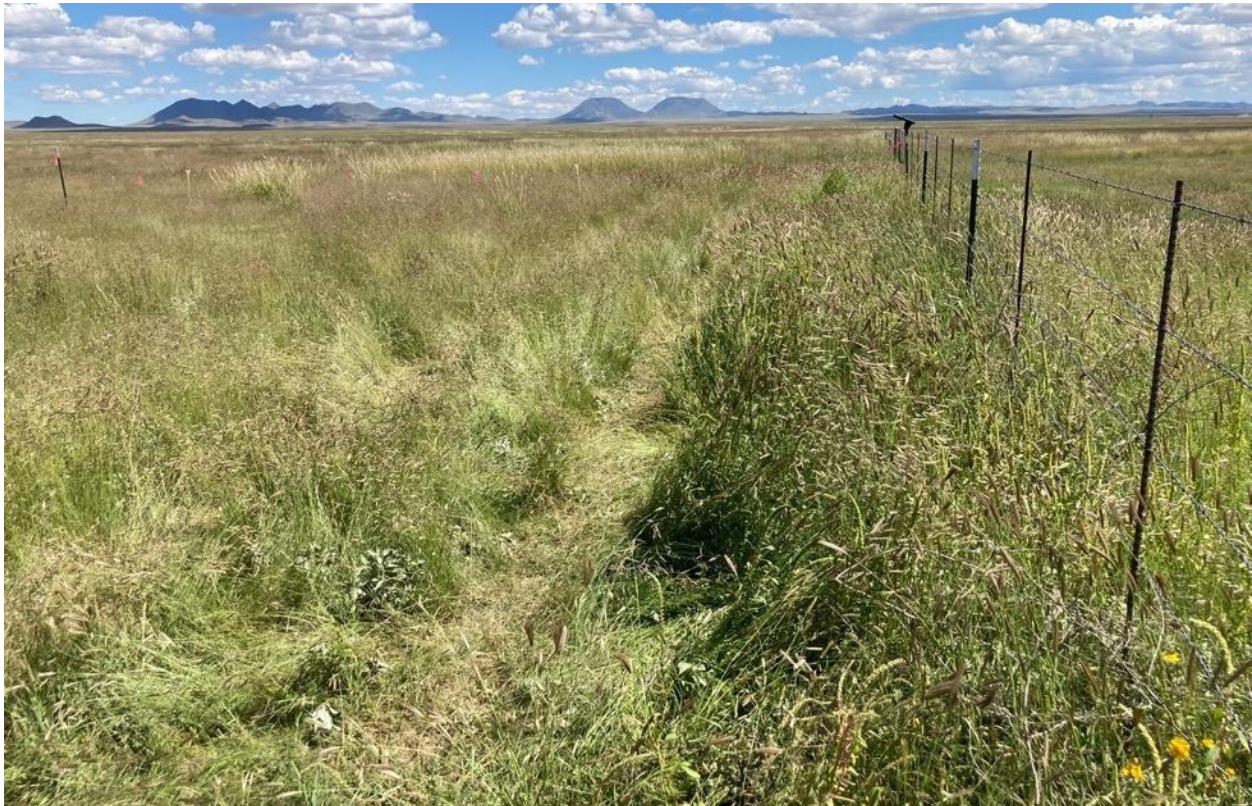
Figure 38. Safe-to-fail trial area in the George Property, pre-treatment, September 2022, (Photo by Philip Boyd)

During the September workshop, staff moved 1,000,000 lbs./ac into a trial paddock for about 3 hours. The trial was conducted on a warm afternoon and yearling heifers and steers were used. They were kept in the working pens and then, after guests attending the workshop could view the trial area before the experiment (*Figure 38*), the yearlings were moved into the paddock. Attendees left to view other parts of the ranch before returning to the trial site where the yearlings were removed. The vegetation was sufficiently trampled, but not much was consumed and there was not much manure left behind, most likely to the stress of the new conditions and the heat of the afternoon (*Figure 39*). The trial area will be monitored over the next year (*Figure 40*).

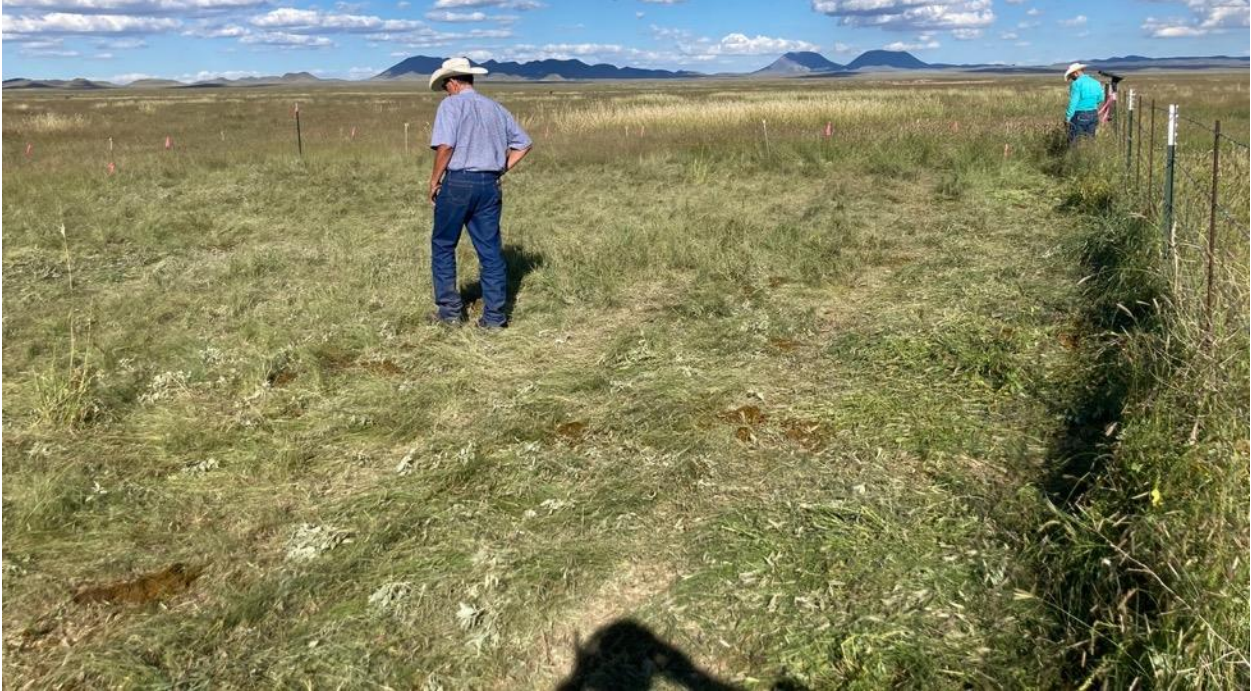
Figure 39. Safe-to-fail trial area in the George Property, post-treatment of 1,000,000 lbs/ac of livestock impact for 3 hours, September 2022, (Photo by Philip Boyd)

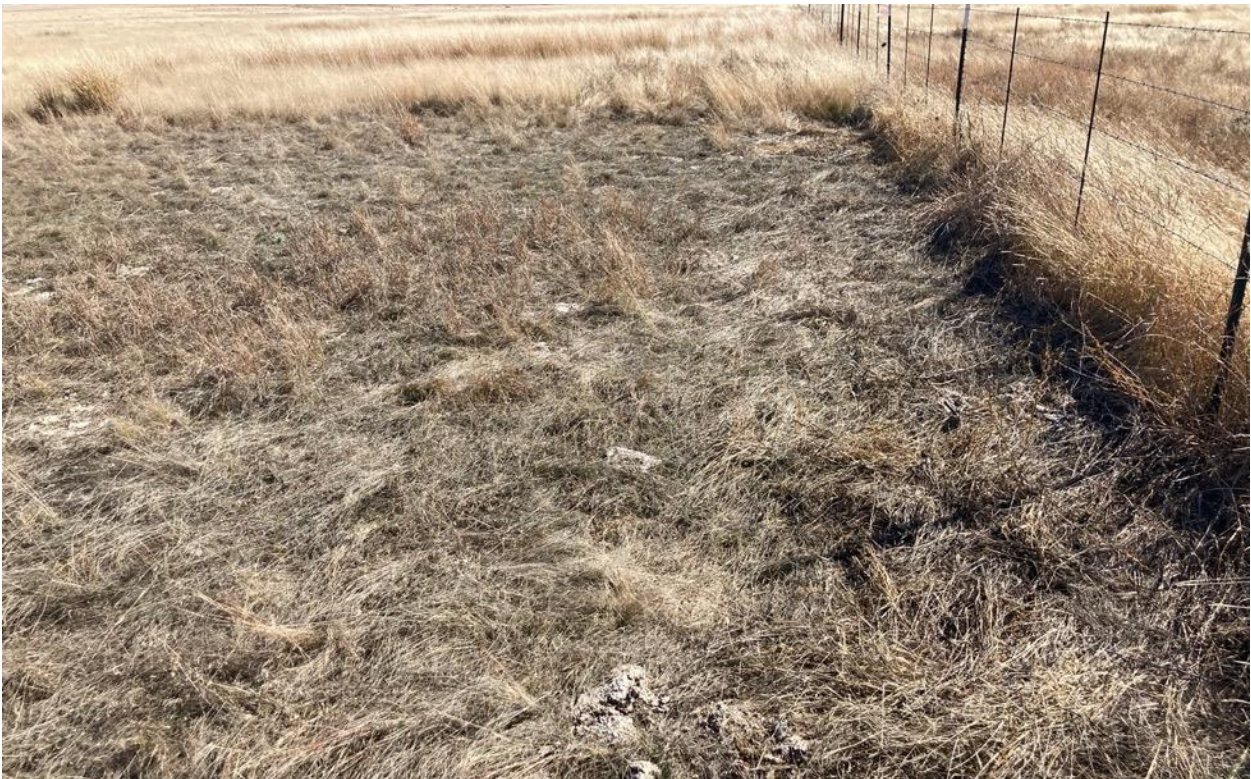
Figure 40. Safe-to-fail trial area in the George Property, 6-weeks post-treatment of 1,000,000 lbs./ac of livestock impact for 3 hours, November 2022, (Photo by Philip Boyd)

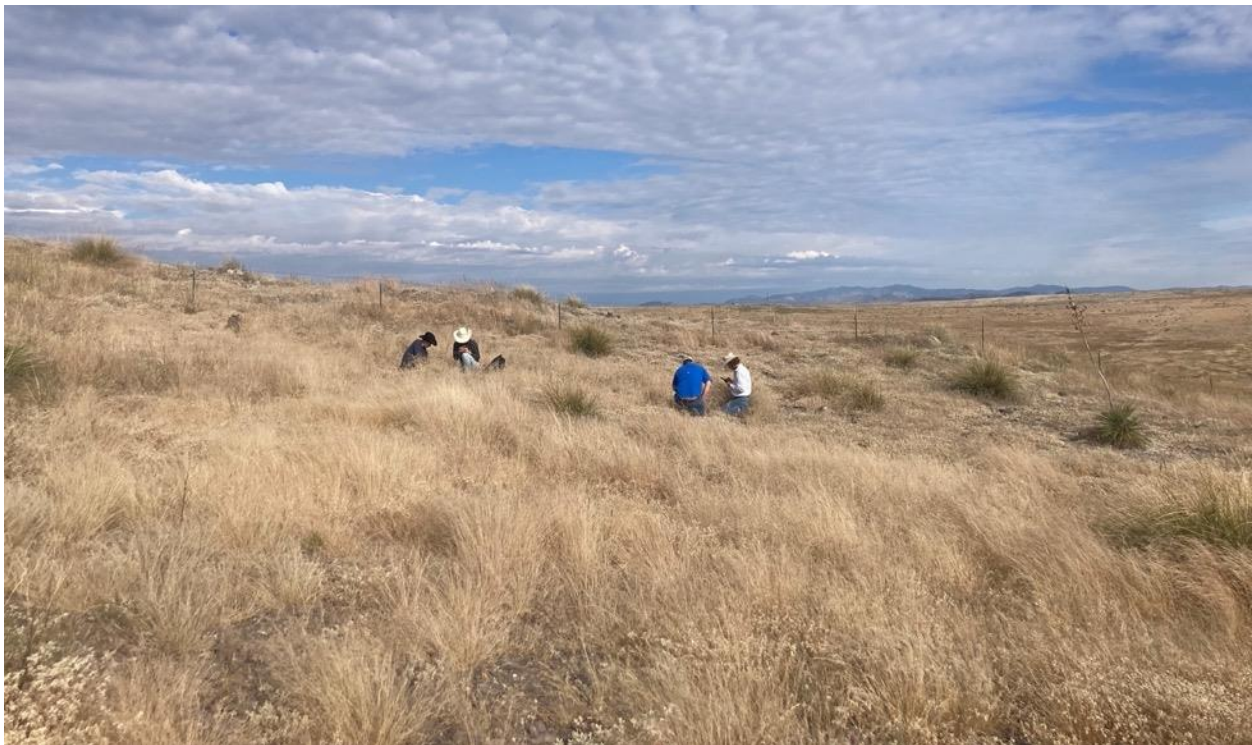
Figure 41. Students from Sul Ross State University stretch a measuring tape to mark a transect for ranch inventory monitoring, Mimms Unit, October 2022 (Photo by Philip Boyd)

Mimms Unit- Dr. Robert Kinucan brought the range inventory class to the Mimms Unit to conduct vegetation surveys in fall 2022 (*Figure 41*). These surveys were part of an annual inventory that takes place across 35 points that include all of the grazing regimes on the ranch. For the past two sampling seasons, the class has focused on sampling half of the total inventory points. The 2022 efforts focused on the southern portion of the ranch.

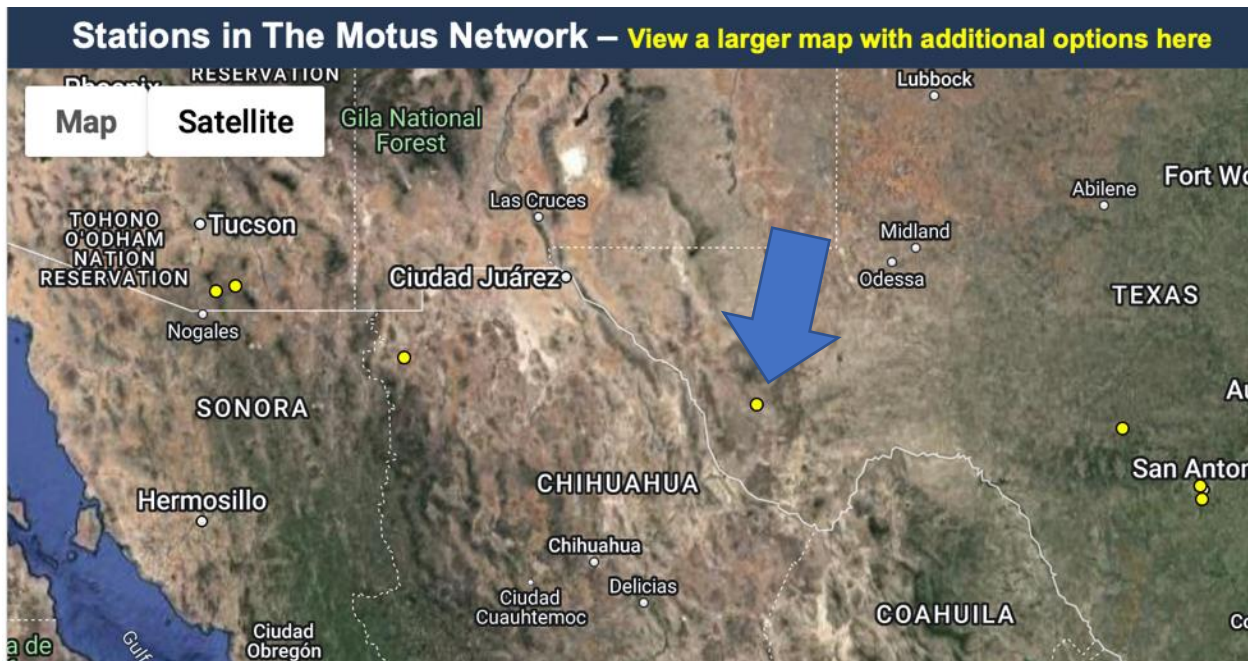
Figure 42. Screenshot from the Motus.org website of Motus station locations. The blue arrow indicates the location of the station on the Mimms Unit.

Mimms Unit Motus Station – In December 2021, Bird Conservancy of the Rockies visited the Mimms Unit to install the first Motus station in the Chihuahuan Desert (*Figure 42*). The placement of the station gives researchers an opportunity to detect migrating birds that may pass within roughly 10 – 12 miles of the station.

Researchers control the level of privacy attached to their data, though all detections are uploaded to a centralized database. The entire network of Motus stations can be viewed on a map hosted on the Motus website (motus.org). The Mimms Motus station remains the only station in the Chihuahuan Desert as of late 2022.

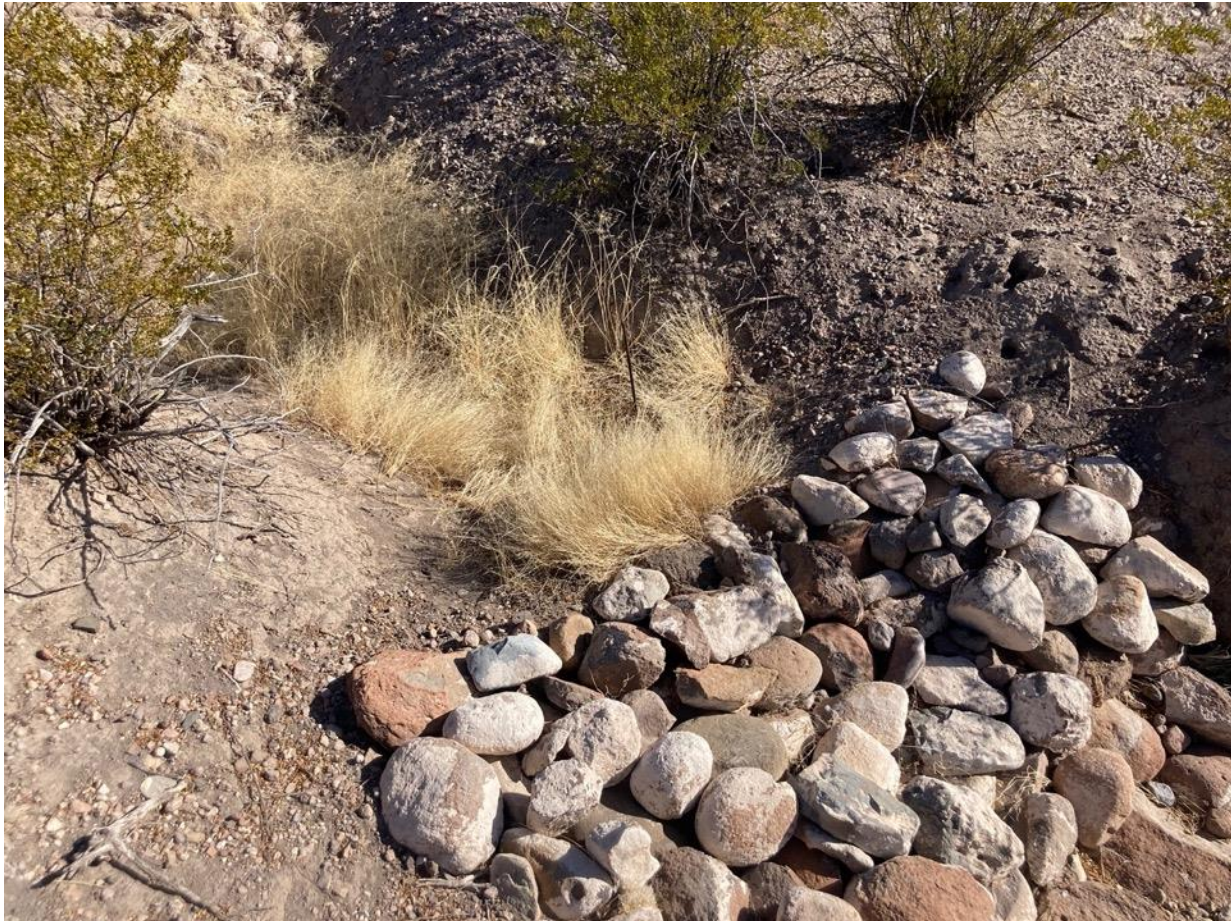
Figure 44. Grass grows behind a leaky-rock dam that was built in an incised tributary at Alamtio Creek Preserve, April 2022. The structure of loose rocks was built in April 2021 and allows water to filter through while also slowing the water, dropping sediment on the upstream side of the structure. This sediment also retains moisture for longer periods of time than a channel in which water passes through quickly during a flashing event. This photo shows the lifted channel resulting from this sediment capture and the resulting vegetation that grew from these conditions in what was formerly an incised and bare channel. (Photo by Philip Boyd)
