Dixon Water Foundation Annual Report - 2022

2022 – ANNUAL REPORT

This report summarizes the efforts taken by Dixon Water Foundation to achieve the goals of their mission in the year 2022.

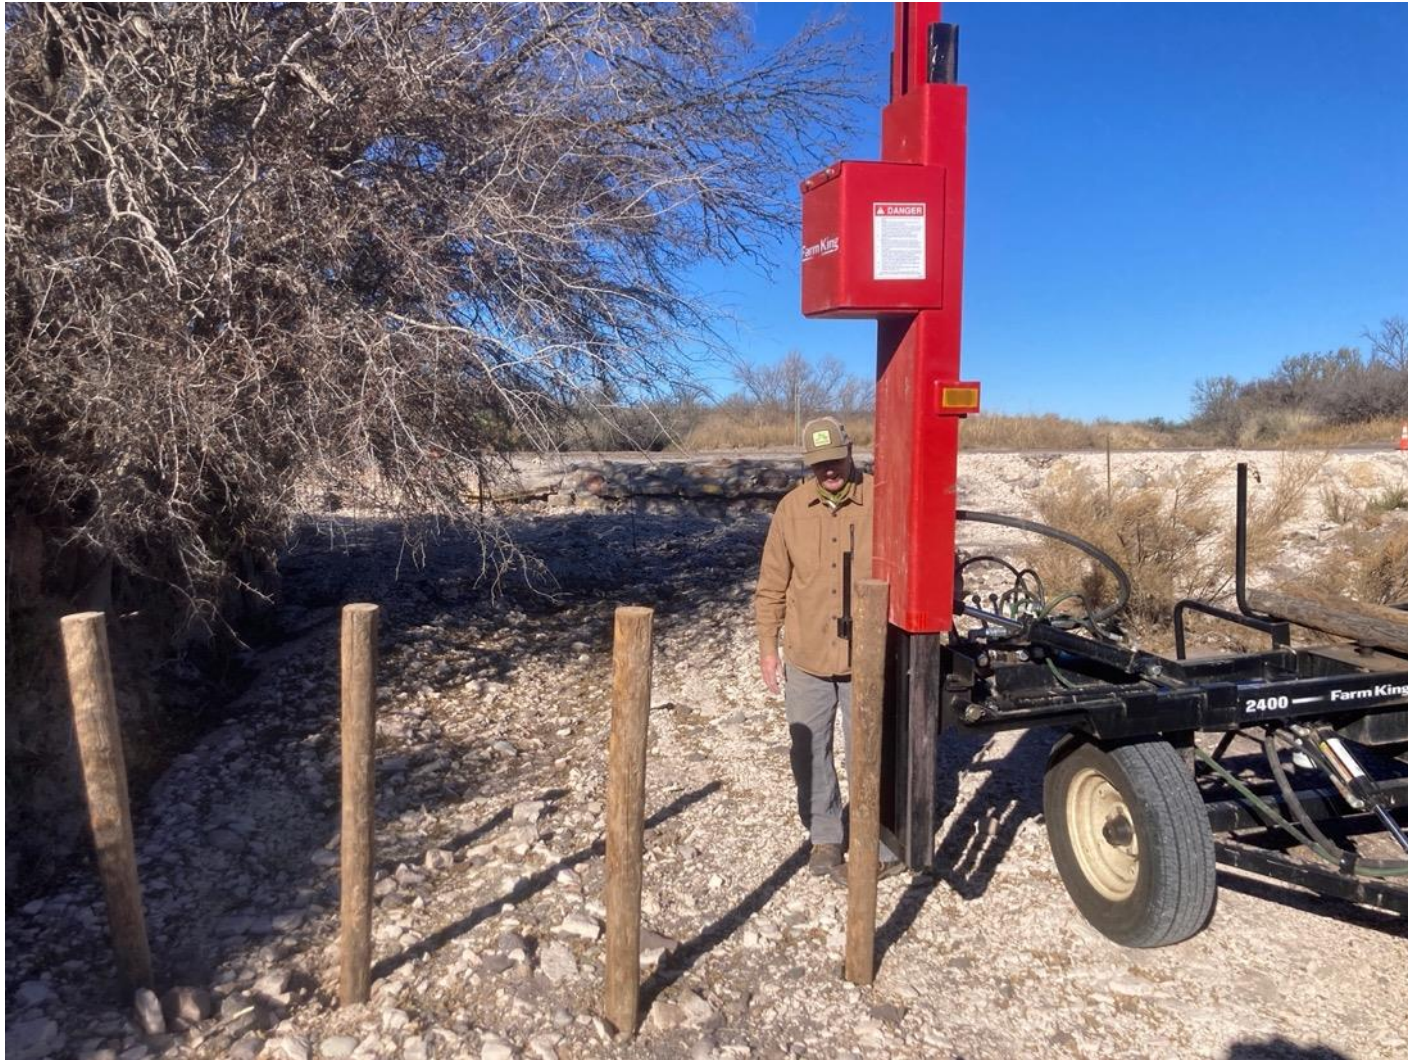
Figure 46. Rio Grande Joint Venture hydrologist Jeff Bennett using a hydraulic post pounder to install brush weirs in Matonoso Creek on Alamito Creek Preserve, October 2022. (Photo by Philip Boyd)

In winter 2022, DWF staff and RGJV staff started installing brush weirs, or beaver dam analogs, into the Matonoso Creek channel of Alamito Creek Preserve (*Figure 45*). These structures utilize the same principles as the loose rock filter dams but are made with wood materials. The structures are built by driving 6’ wooden posts into the creek bed using a hydraulic post pounder

and then weaving brush trimmings into the posts (*Figure 46 and Figure 47*). A series of these structures will be built in the channel to slow flood water and increase residence time of water in the channel. Increased residence of water can create potential aquatic habitat and increase potential ground water recharge time by allowing the water more opportunity to soak into the gravel creek bed. Additionally, the reduced velocity of water decreases erosive forces that further disconnect the creek channel itself from floodplains.

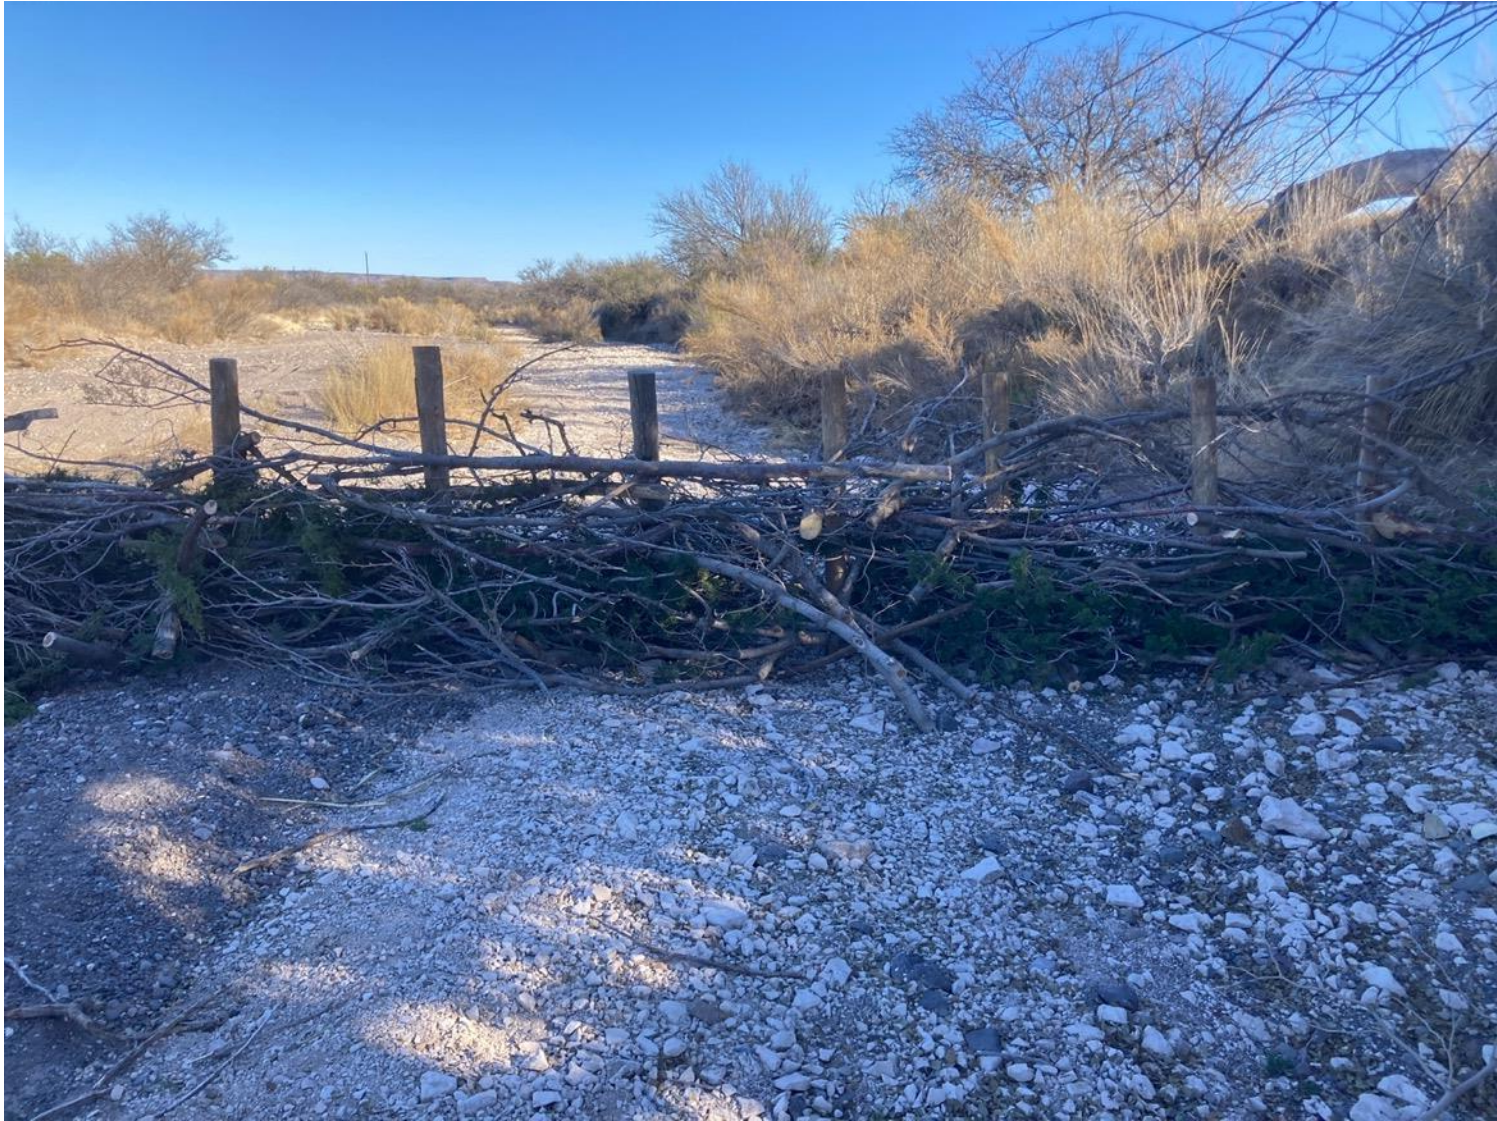
Figure 47. A completed brush weir structure composed of 6' pine posts woven with brush trimmings, in Matanoso Creek on Alamito Creek Preserve, December 2022. (Photo by Philip Boyd)
