# DIXON WATER FOUNDATION

2023 ANNUAL REPORT

**The Dixon Water Foundation promotes healthy watersheds through sustainable land management to ensure that future generations have the water resources they need.**

**This report summarizes the efforts taken by Dixon Water Foundation to achieve the goals of this mission in the year 2023.**

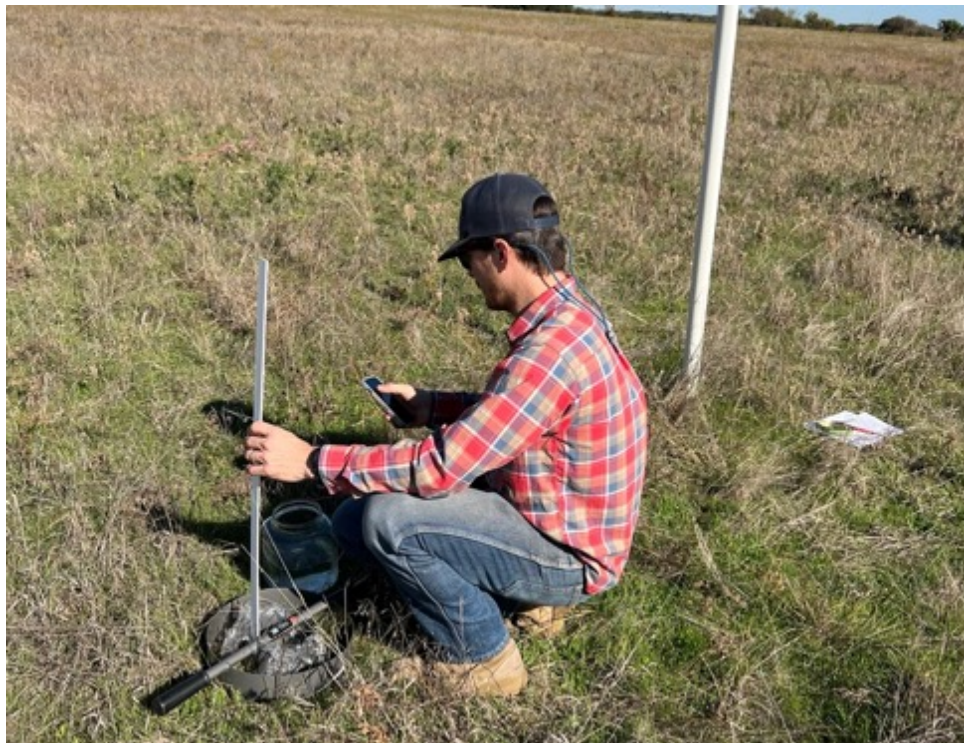
***Figure 5. Philip Boyd, Vice President of Science and Research, records infiltration rates for a monitoring point on the Leo Unit in North Texas (Photo by Hilary Knight).***

Additionally, Foundation staff began collecting infiltration rate data during the biological monitoring process (*Table 1*). The sampling point was randomly chosen within a 6' radius of the PVC-covered t-post marking each biological monitoring point. The bearing to the point was recorded. Infiltration rates were measured by using a 6" x 12" AMS infiltration ring. Water was poured into the outer 12" ring to begin saturating soil. A layer of plastic was laid into the 6" ring and 1" of water was poured onto the plastic. The plastic was removed while simultaneously starting a stopwatch. Once all visible water had soaked into the soil, the stopwatch was stopped, and time was documented. The process was repeated to get a second measurement. The second measurement gives a better estimate of infiltration rate after the first measurement has wet the soil. This process is based on the USDA's *Soil Quality Test Kit Guide* (2001). The points were photographed to document ground cover composition.

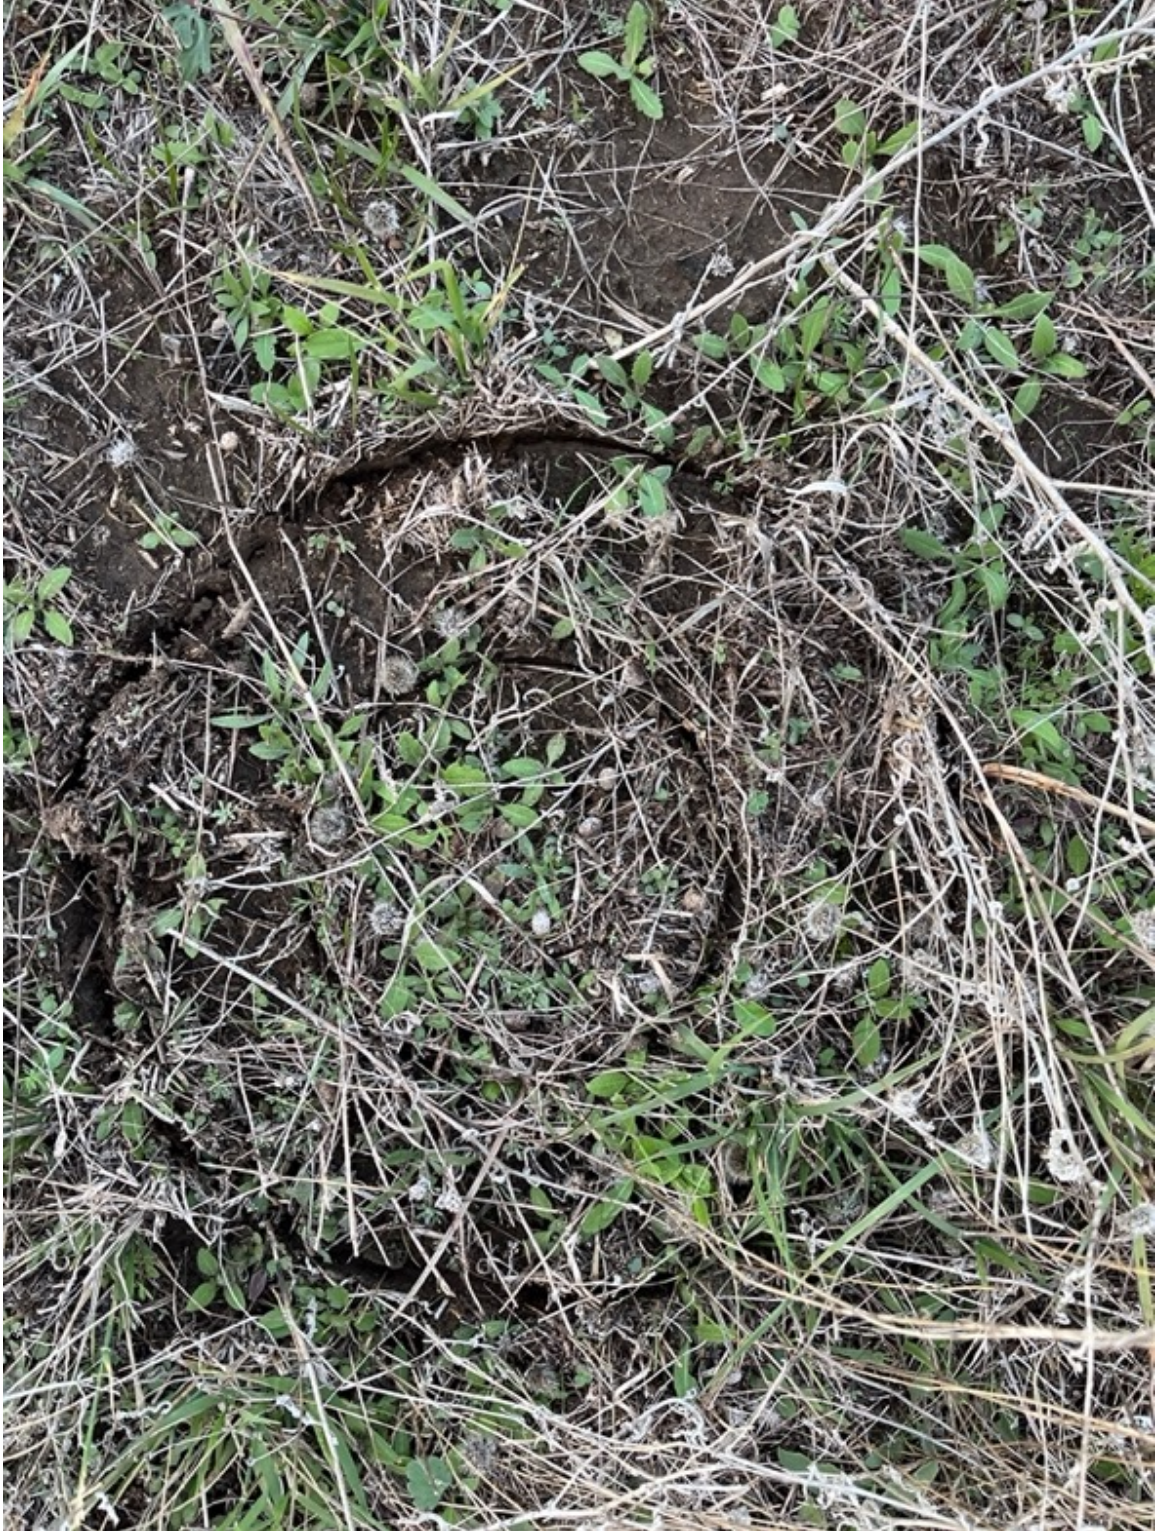
*Figure 6. After infiltration rates were recorded, photographs were taken to document vegetative ground coverage at each of the sampling sites. This photograph shows a sampling site at the Leo Unit “Aunt Ann’s” monitoring point, near the Josey Pavilion, Fall 2023. (Photo by Philip Boyd)*

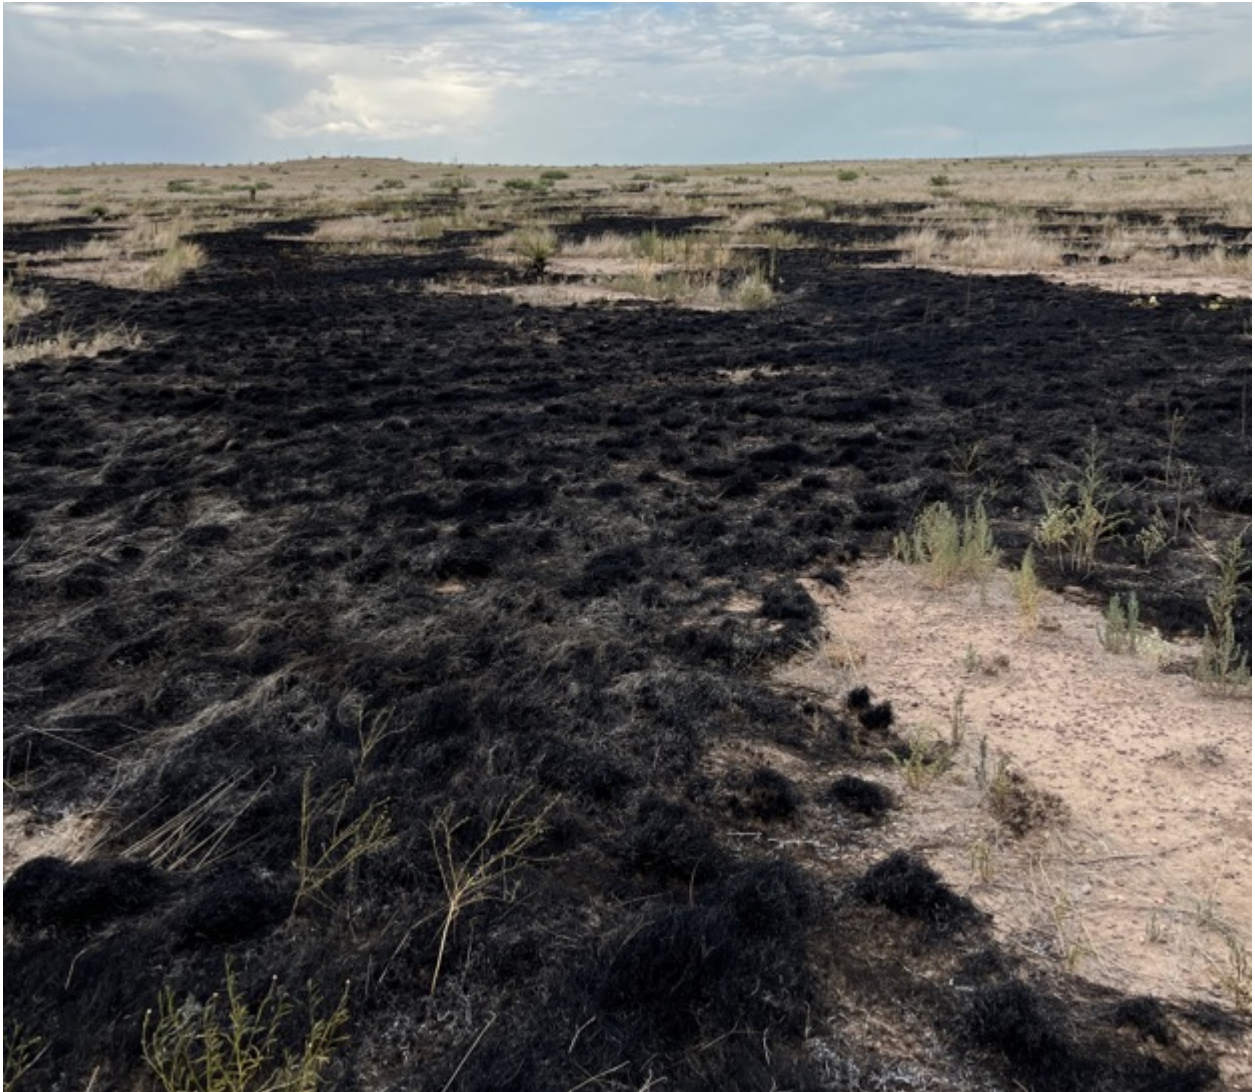
*Figure 15 – Photo of 4-acre wildfire site on western edge of Mimms Unit, Marfa, Texas, July 31, 2023. Latitude: 30° 21' 11.568" N, Longitude: 104° 4' 26.72" W. (Photo by Philip Boyd)*

A small wildfire broke out on July 31, 2023 on the western edge of the Mimms. The fire burned about 4 acres and was quickly extinguished by the Marfa Volunteer Fire Department who spotted the fire, caused by a dry lightning strike, while operating nearby (*Figure 15*).

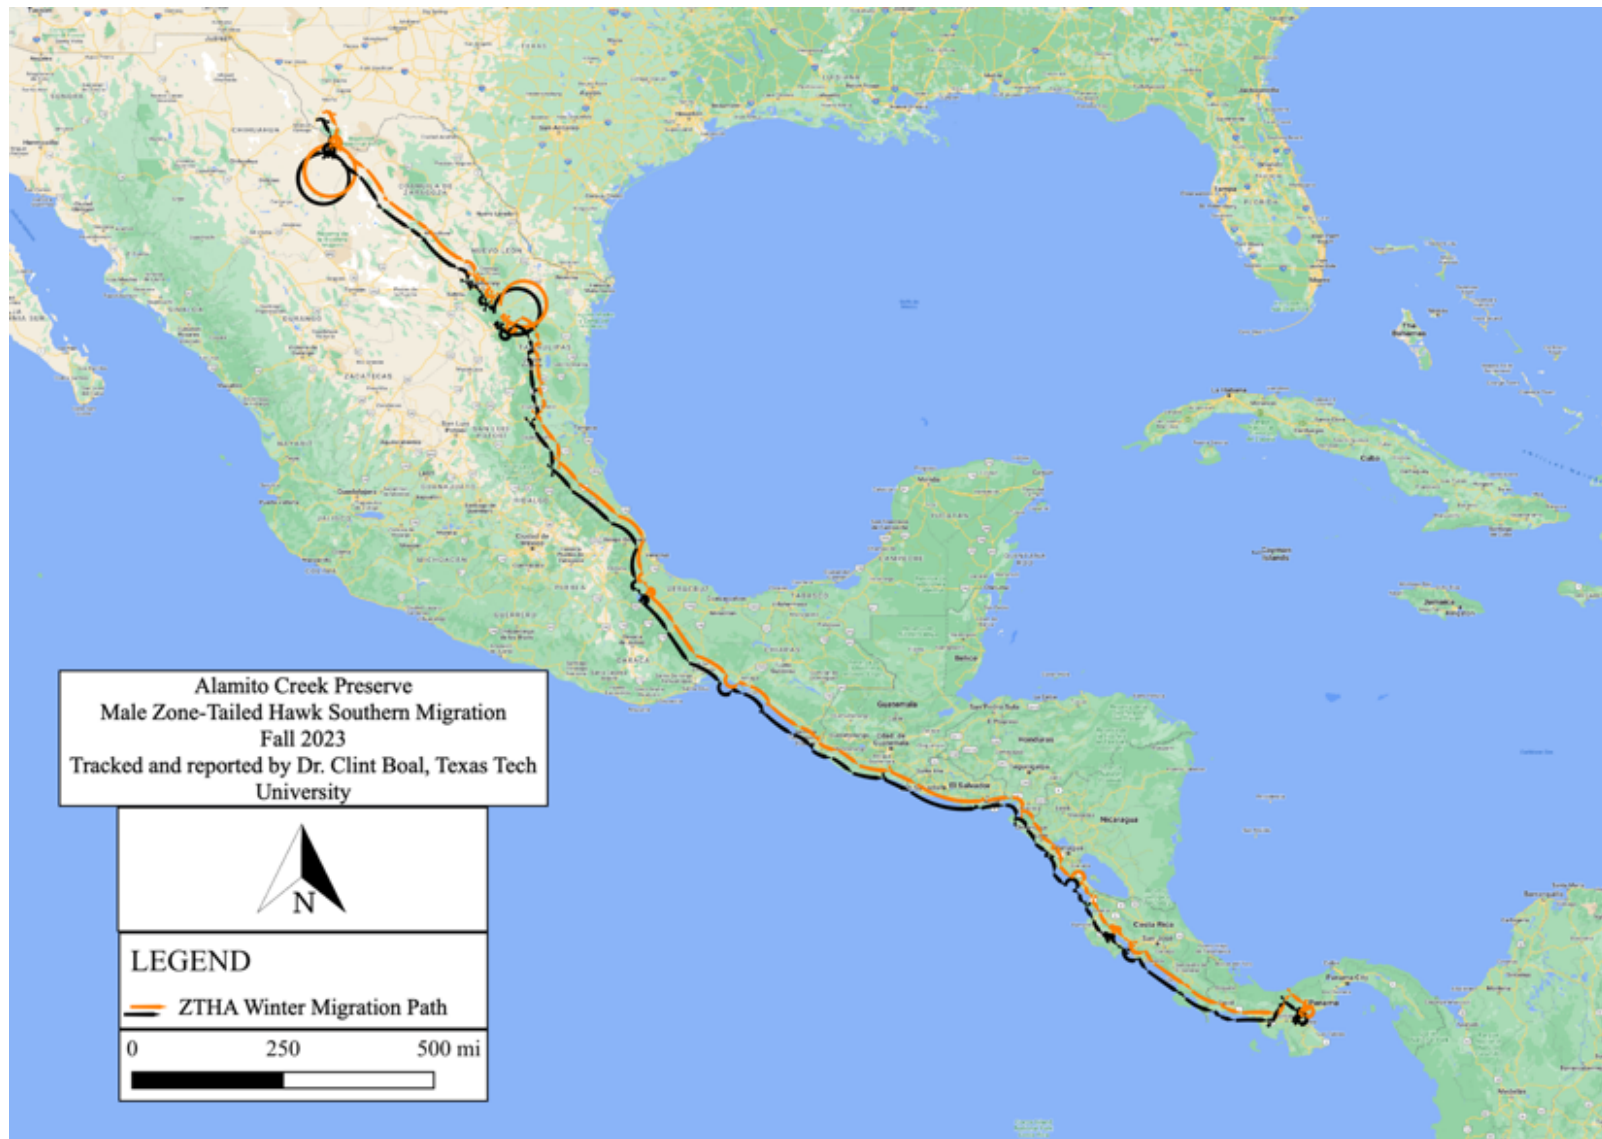
*Figure 34. A map shows the fall southern migration path of a Zone-Tailed Hawk that was affixed with a GPS tracking backpack on the Alamito Creek Preserve in June 2023. The bird traveled from Presidio County, Texas to Panama in Central America.*

The Alamito Creek Preserve hosts at least two pairs of nesting zone-tailed hawks (ZTHAs) during the breeding season. Trail camera photos indicate that the birds arrive in March of each year and depart in late August. Dr. Clint Boal, of Texas Tech University, is studying the migration patterns of ZTHAs using GPS backpacks and the Foundation allowed Dr. Boal to deploy a backpack on one of the males from the Preserve in summer of 2023. In the fall of 2023, the ZTHA had left the Preserve in Far West Texas and had flown to Panama in Central America. According to Dr. Boal, this was the southernmost known migration of North American ZTHAs (*Figure 34*).

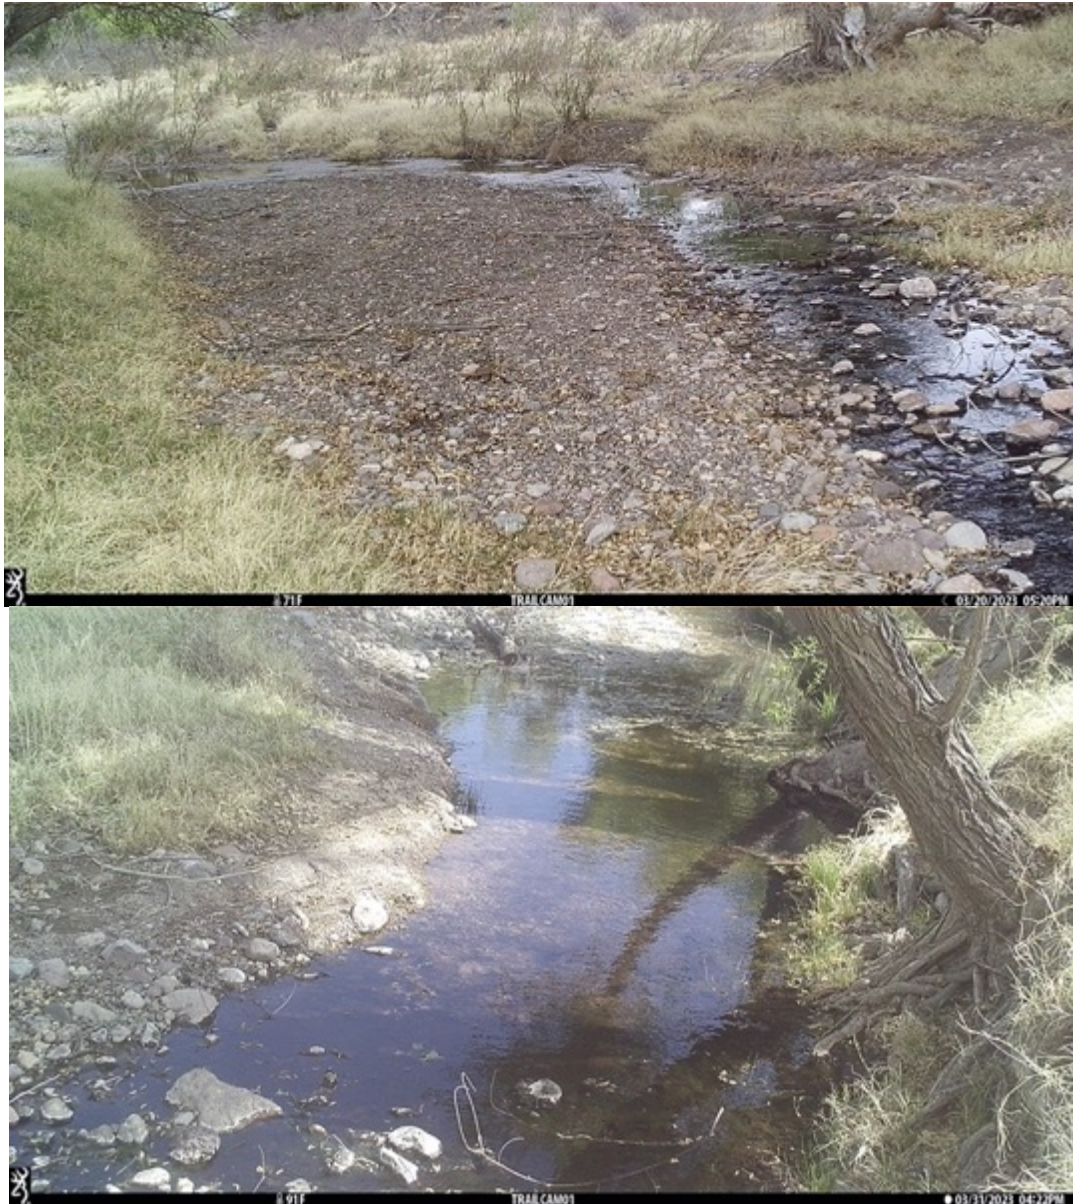
*Figure 36. A camera facing upstream on Alamito Creek captures persistent overland flow from a small spring-fed pool (top) which flows into a second pool downstream (bottom), captured by a second trail camera. These pools and overland flow persisted from August 2022 until June 2023.*

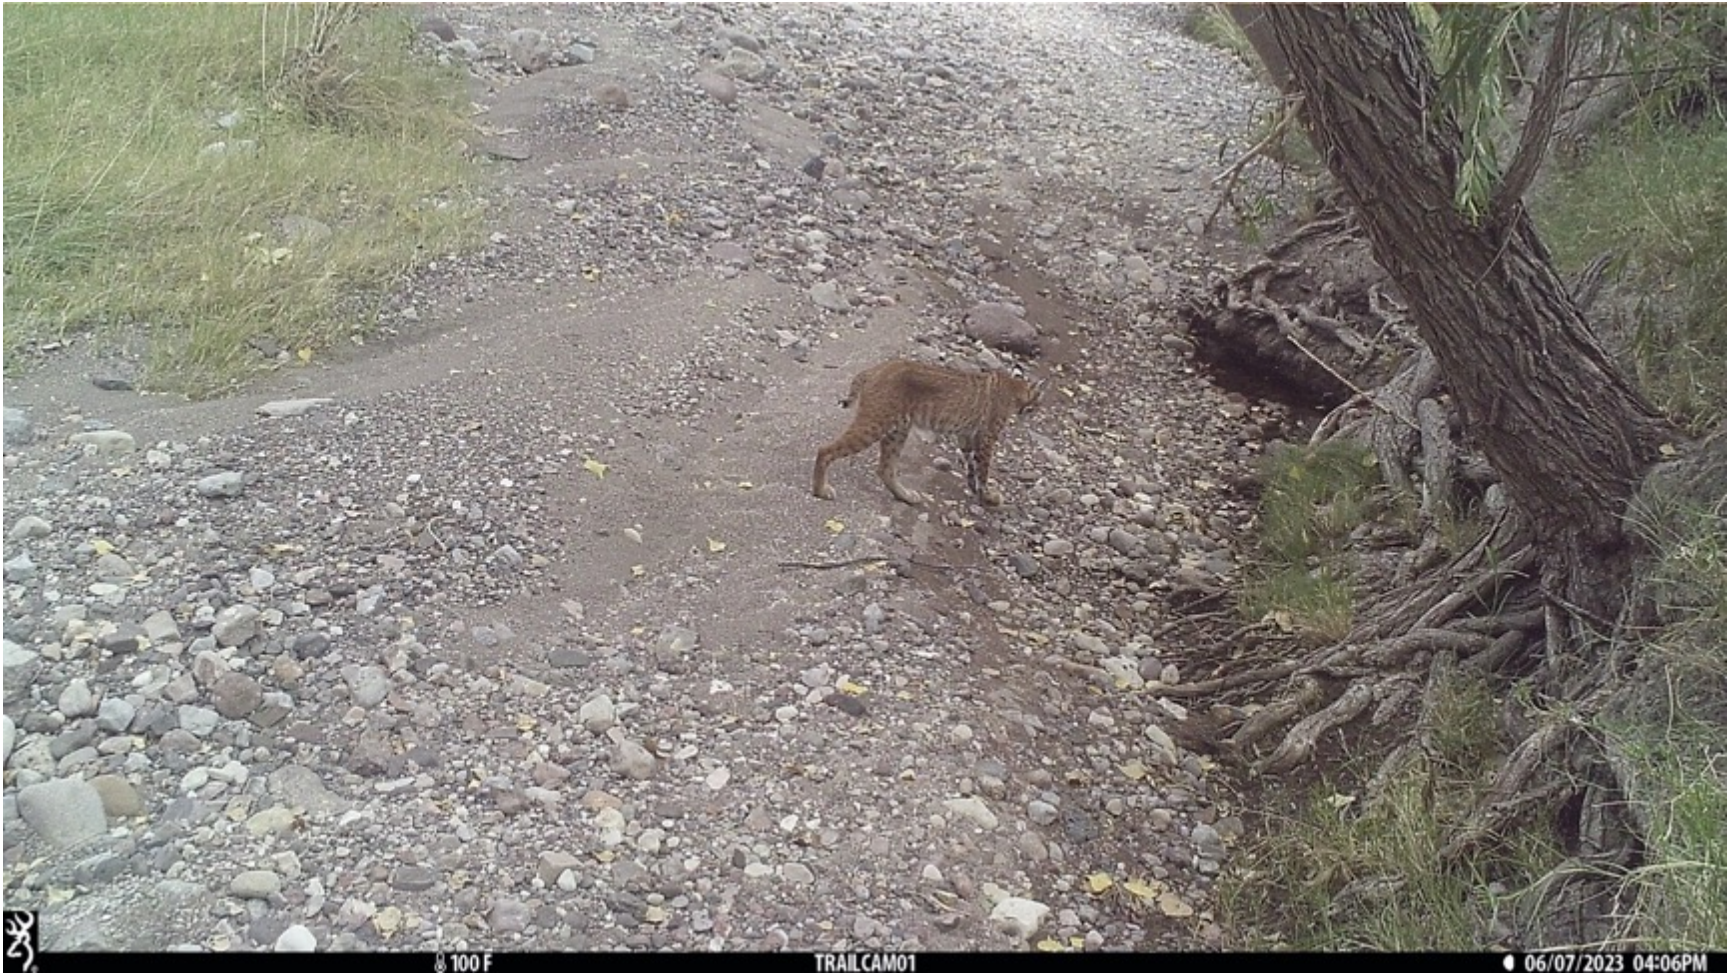
*Figure 37. A trail camera facing downstream on Alamito Creek shows a bobcat approaching the spring-fed pool site which has gone dry June 2023. Water sometimes seeps beneath the tree roots along the creek bank and is most likely the discharge point of a small spring, and a water source known to wildlife.*

The Foundation uses trail cameras to monitor activity at the Preserve. In August of 2022, flood waters appeared to fill and recharge the small spring-fed pools that the trail cameras are aimed at. Overland flow connected two pools with flow extending several hundred yards downstream (*Figure 36*). The southernmost trail camera pool hosted some fish, of which only 1 bluegill was identified, and various insects for several months. By June of 2023 the pool had dried up (*Figure 37*). The cameras captured 2 flood events in 2023, in May and in July (*Figure 38*).

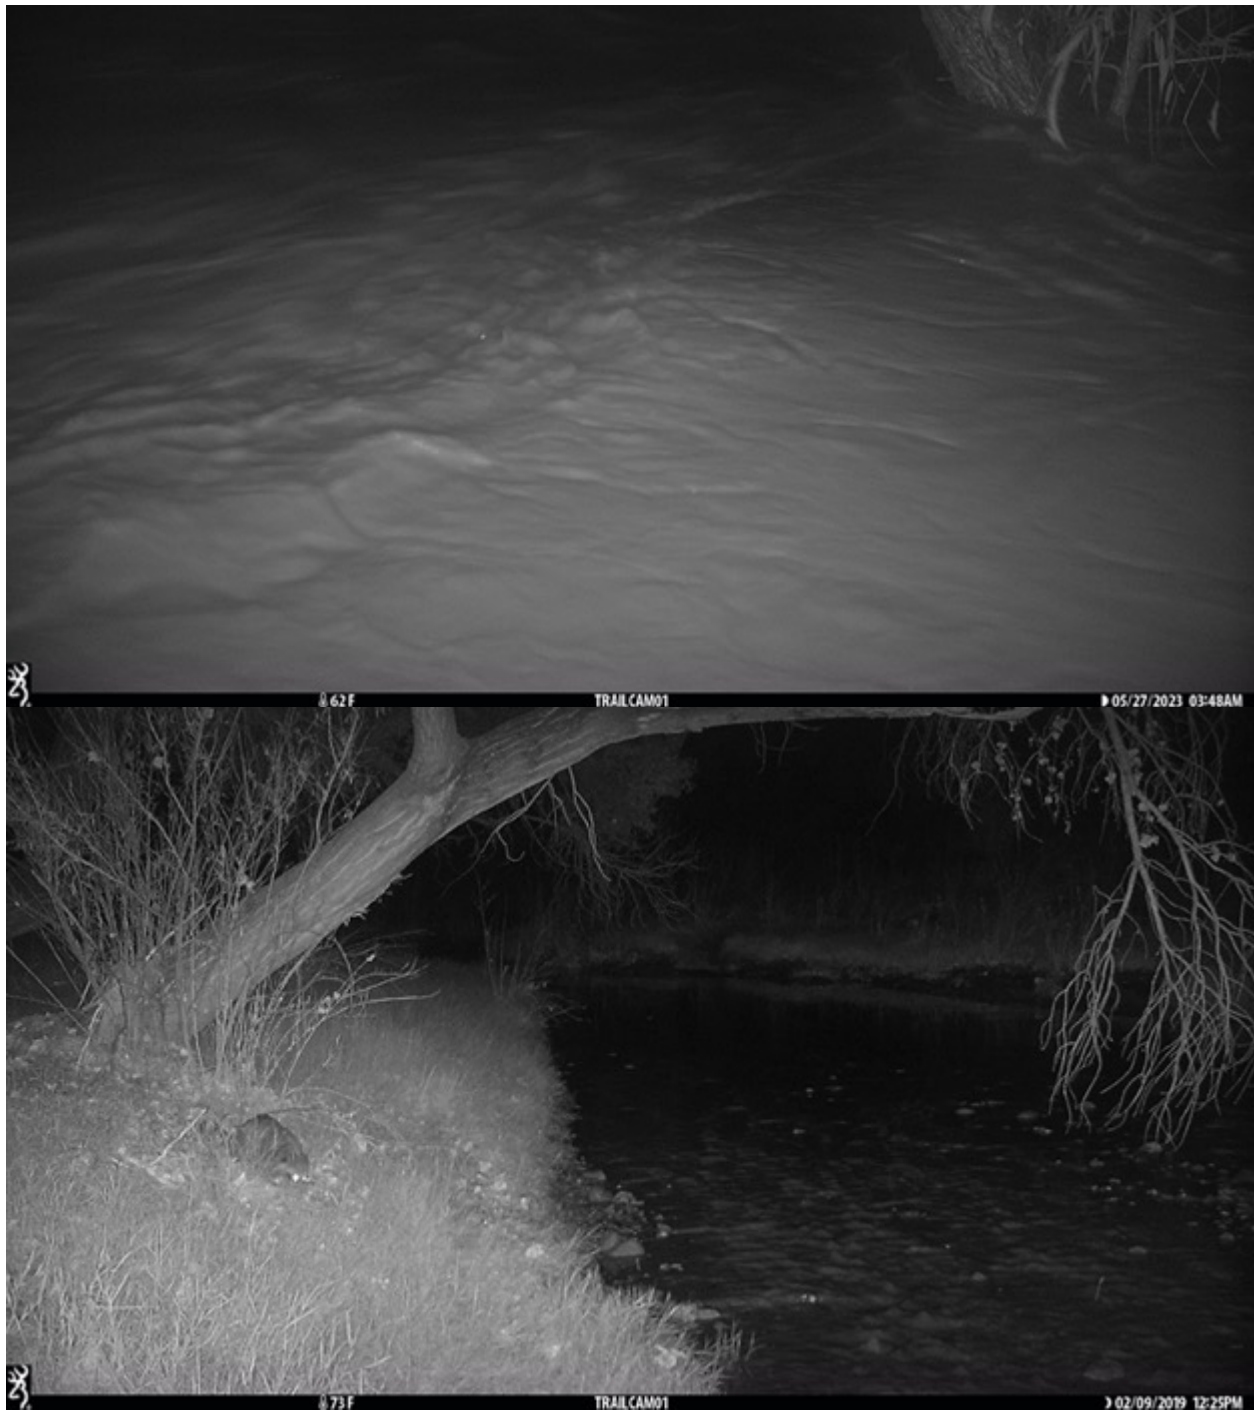
*Figure 38. Trail cameras capture flood events in the Alamito Creek channel in May 2023 on the downstream-facing camera (top) and in July 2023 on the upstream-facing camera (bottom, \*photo is tagged with incorrect date).*

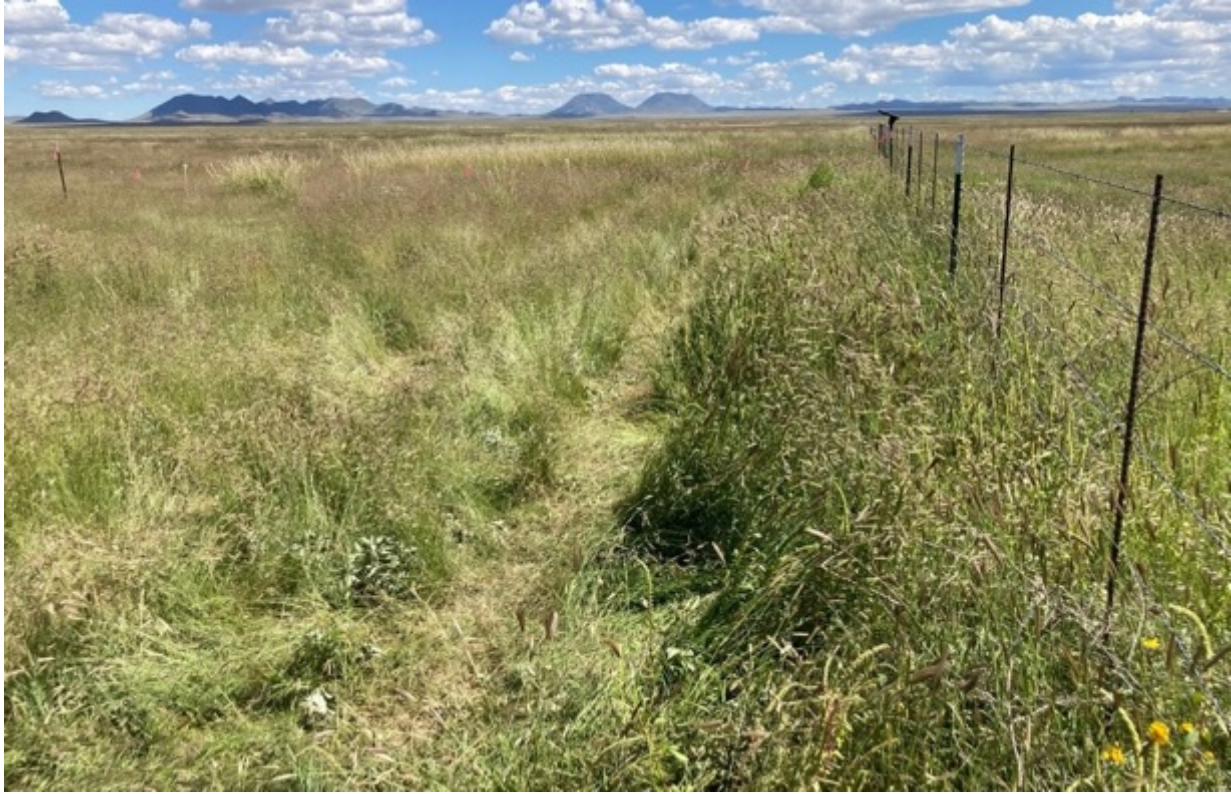
***Figure 41. Safe-to-fail trial area in the George Property, pre-treatment, September 2022, (Photo by Philip Boyd)***

During the September workshop, staff moved 1,000,000 lbs./ac into a trial paddock for about 3 hours. The trial was conducted on a warm afternoon and yearling heifers and steers were used. They were kept in the working pens and then, after guests attending the workshop could view the trial area before the experiment (*Figure 41*), the yearlings were moved into the paddock. Attendees left to view other parts of the ranch before returning to the trial site where the yearlings were removed. The vegetation was sufficiently trampled, but not much was consumed and there was not much manure left behind, most likely to the stress of the new conditions and the heat of the afternoon (*Figure 42*). The trial area will be continually monitored with new treatment sites to be added. (*Figure 43, Figure 44*).

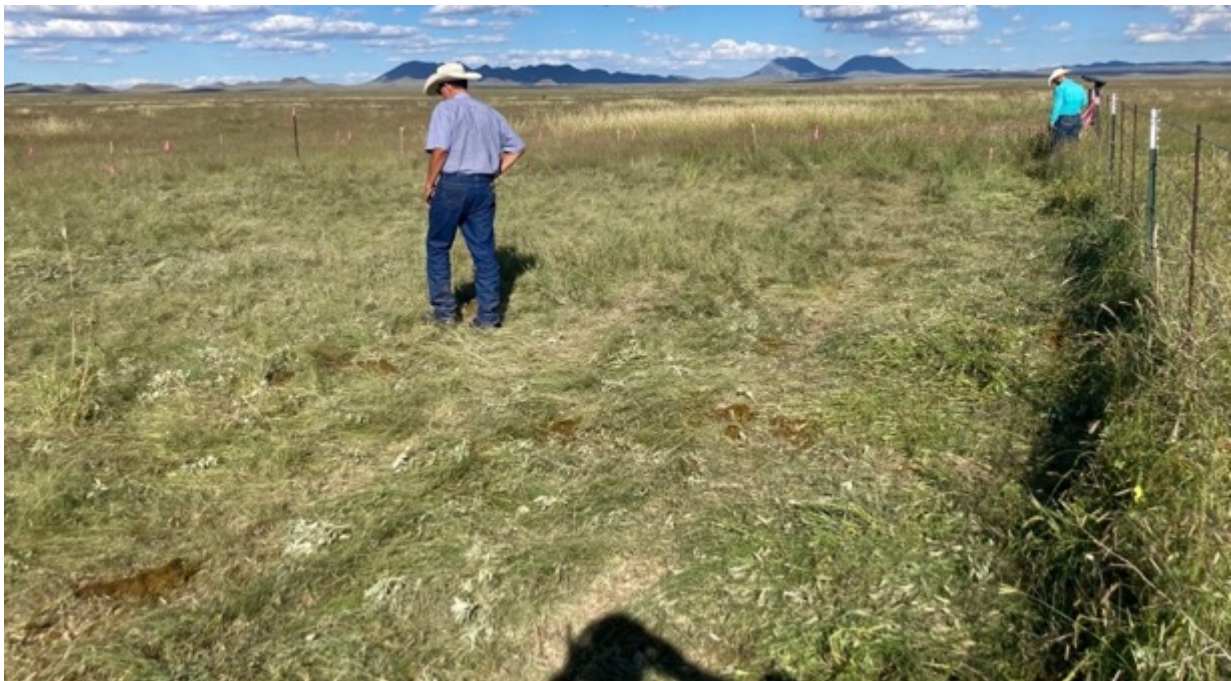
***Figure 42. Safe-to-fail trial area in the George Property, post-treatment of 1,000,000 lbs/ac of livestock impact for 3 hours, September 2022, (Photo by Philip Boyd)***

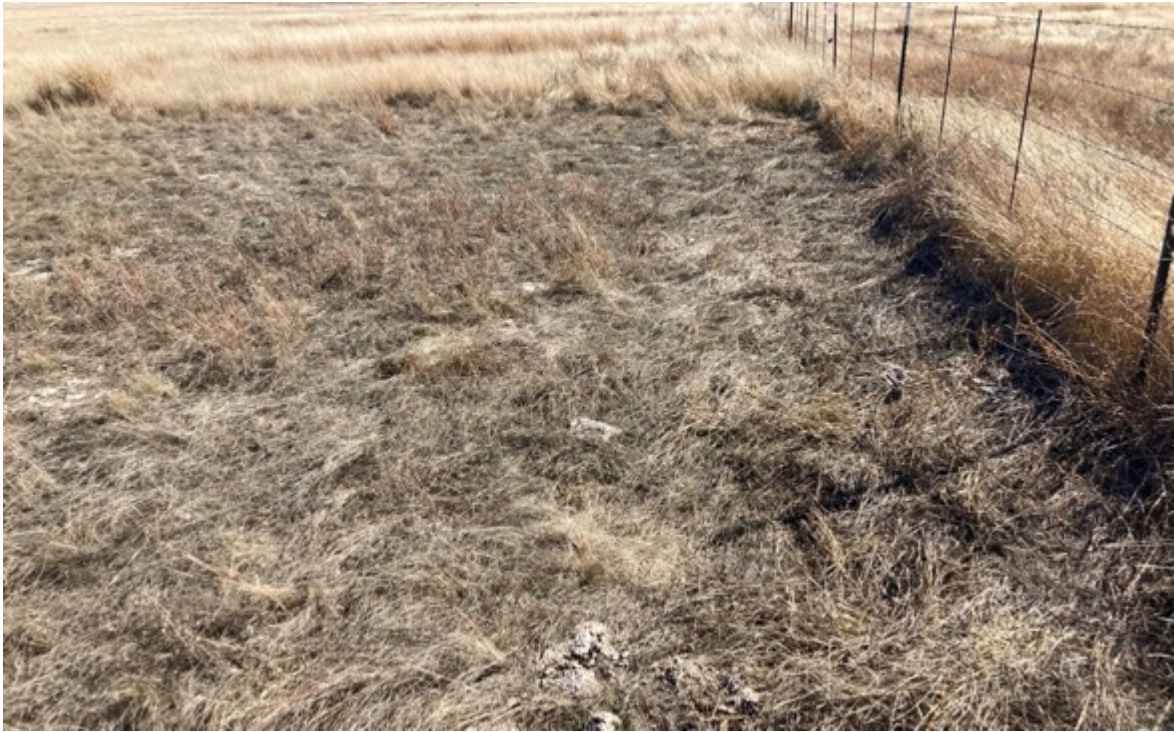
***Figure 43. Safe-to-fail trial area in the George Property, 6-weeks post-treatment of 1,000,000 lbs./ac of livestock impact for 3 hours, November 2022, (Photo by Philip Boyd)***

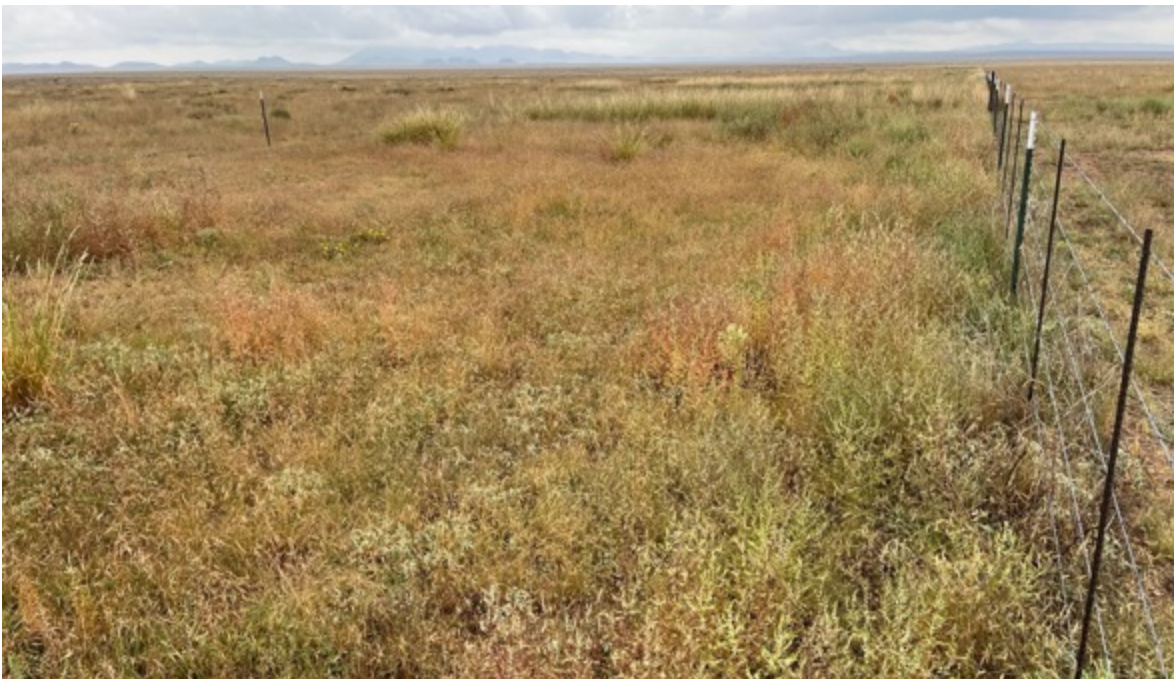
***Figure 44. Safe-to-fail trial area in the George Property, 56-weeks post-treatment of 1,000,000 lbs./ac of livestock impact for 3 hours, October 2023, (Photo by Philip Boyd)***

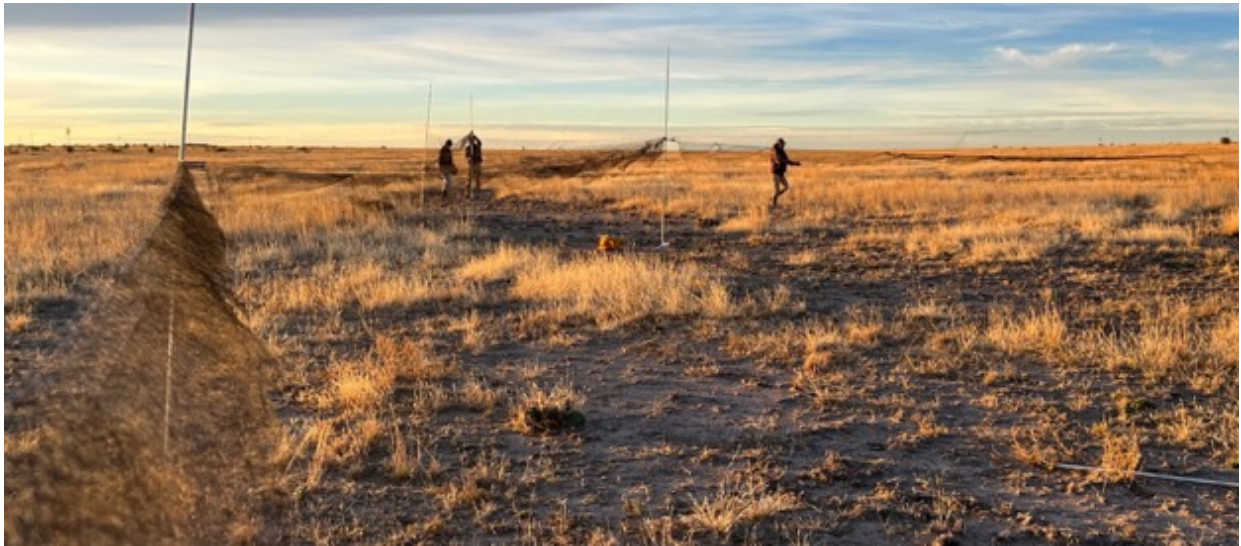
**Figure 46.** *Bird Conservancy of the Rockies bird-banders set up a mist net on the Mimms Unit, Marfa, Texas, Winter 2023.*

**Mimms Unit Banding** – The Bird Conservancy of the Rockies arrived in early December 2023 and used the Mimms Unit and Alamito Creek Preserve to practice plant identification for their surveys. A crew also worked through the season to band birds and affix radio transmitters to key species to track their migration movements through methods like the Motus tower mentioned above (*Figure 46 and Figure 47*).

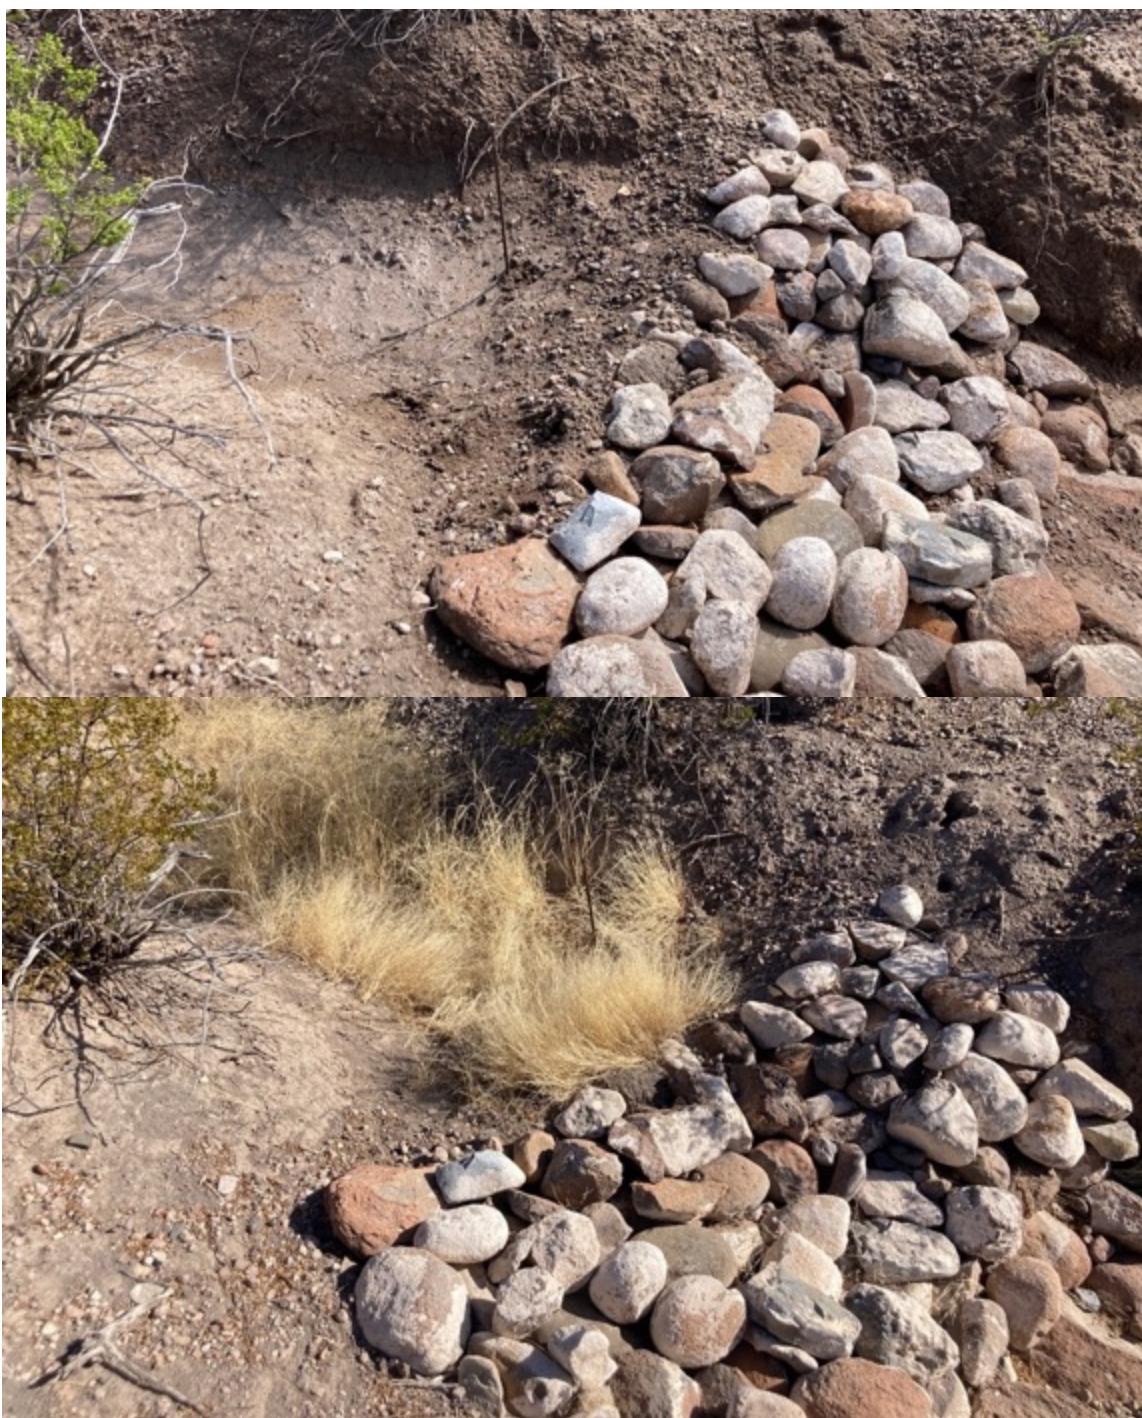
***Figure 48. Photographs of a leaky rock structure built in April 2021 on the Alamito Creek Preserve.. The top photo shows the structure one month after construction and after a recent rain. In 2023, new plant growth on the upstream side of the structure can be seen (bottom photo) where water has been slowed and sediment has been dropped and collected. (These structures of examples of low-tech approaches to restoring eroded sites as they help slow water and capture sediment that would normally be carried away in runoff).***

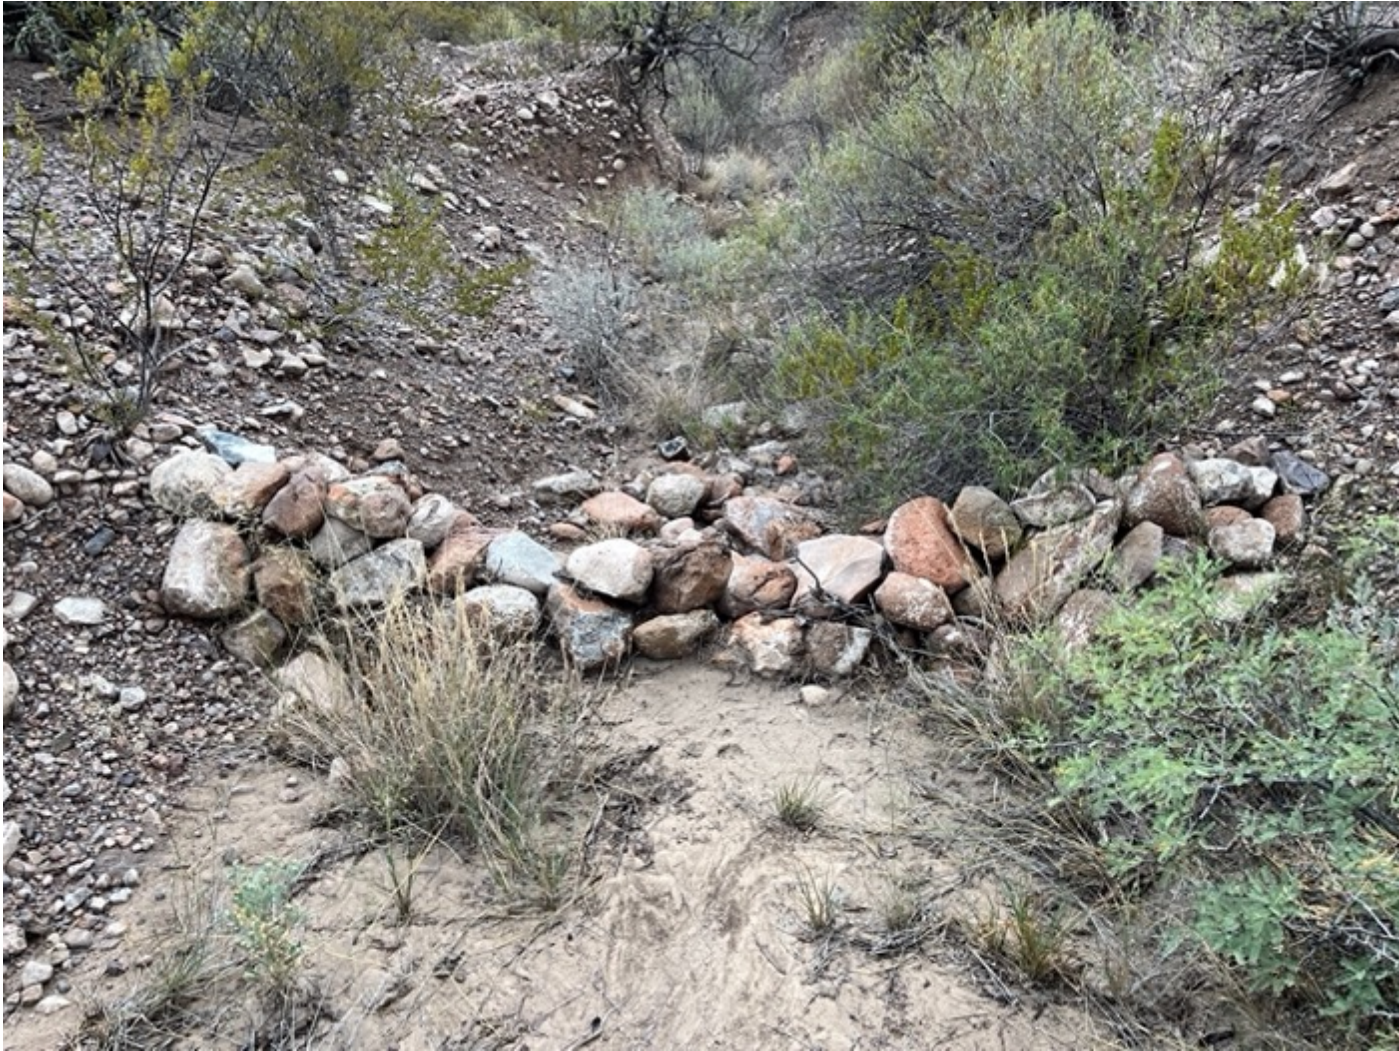
*Figure 49. Photograph taken November 2023 facing downstream from the upstream side of leaky rock structure built in 2021 on the Alamito Creek Preserve. This photo shows newly piled sediment on the upstream side with grasses growing through the soil. These structures are examples of low-tech approaches to restoring eroded sites as they help slow water and capture sediment that would normally be carried away in runoff.*

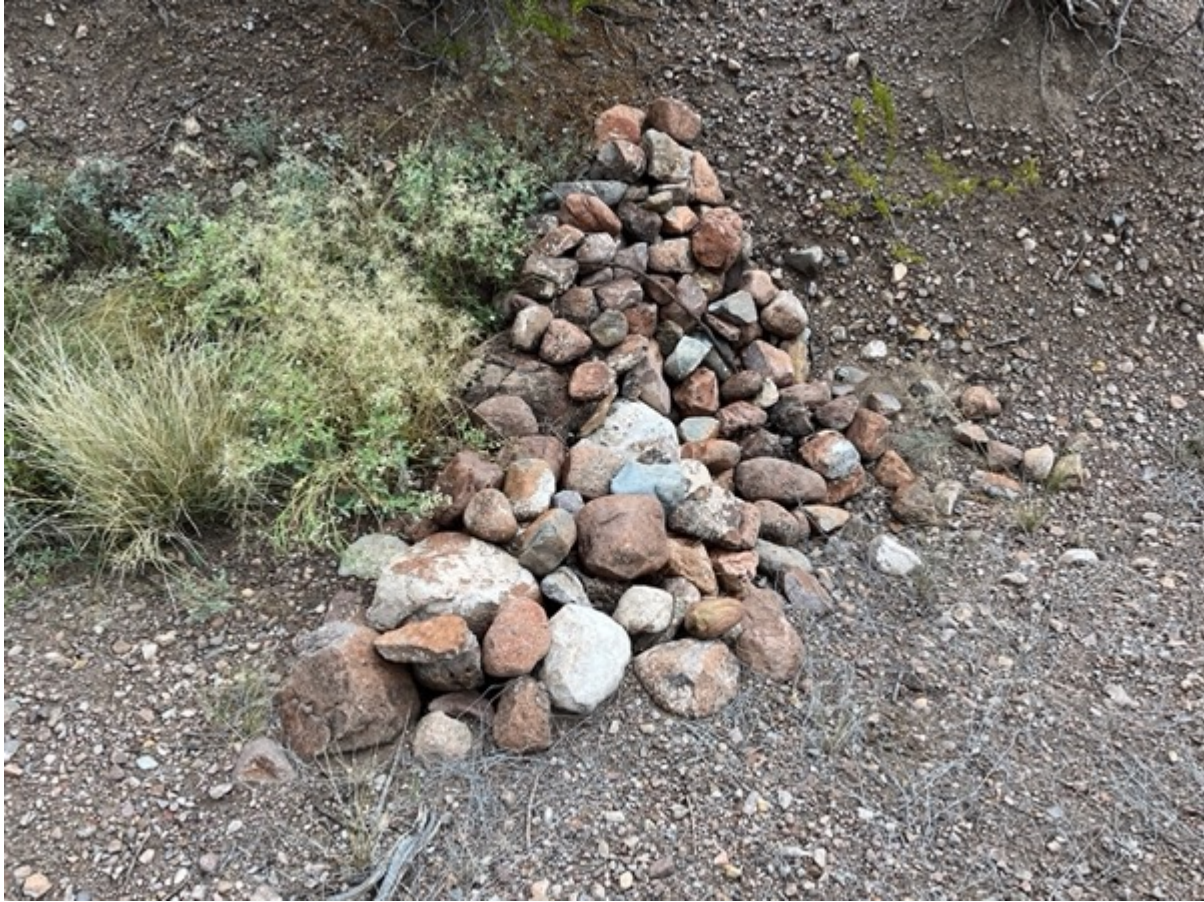
***Figure 50. Grass grows behind a leaky-rock dam that was built in an incised tributary at Alamito Creek Preserve, April 2021. These structures allow water to filter through while also slowing the water, dropping sediment on the upstream side of the structure. This sediment also retains moisture for longer periods of time than a channel in which water passes through quickly during a flashing event. This photo shows the lifted channel in 2023, resulting from this sediment capture and the resulting vegetation that grew from these conditions in what was formerly an incised and bare channel. (Photo by Philip Boyd)***

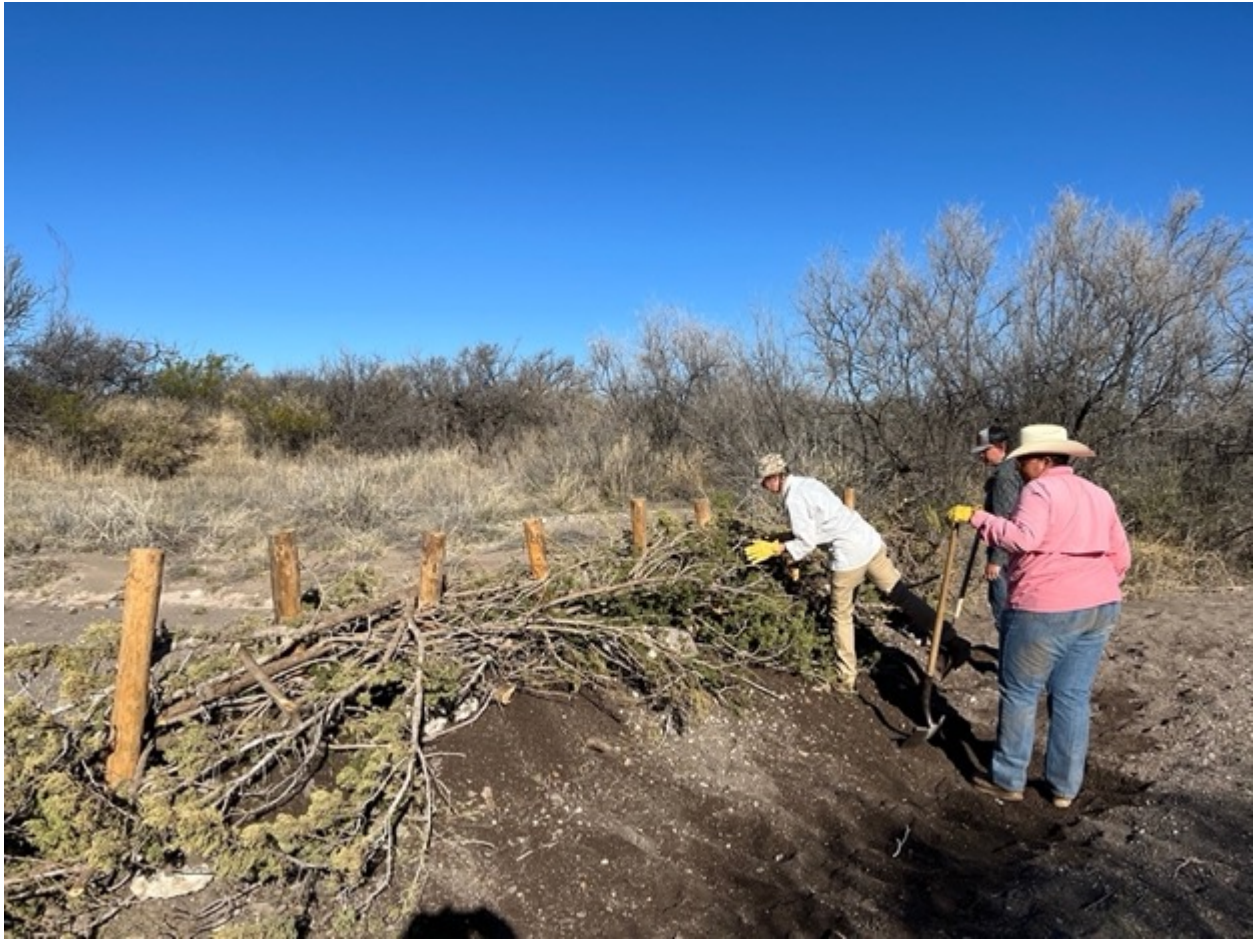
***Figure 51. Sul Ross State University Students visit the Alamito Creek Preserve during a field trip for their Hydrology course to help install experimental brush weir structures with the Rio Grande Joint Venture. (Photo by Philip Boyd)***
