# DIXON WATER FOUNDATION

2023 ANNUAL REPORT

**The Dixon Water Foundation promotes healthy watersheds through sustainable land management to ensure that future generations have the water resources they need.**

**This report summarizes the efforts taken by Dixon Water Foundation to achieve the goals of this mission in the year 2023.**

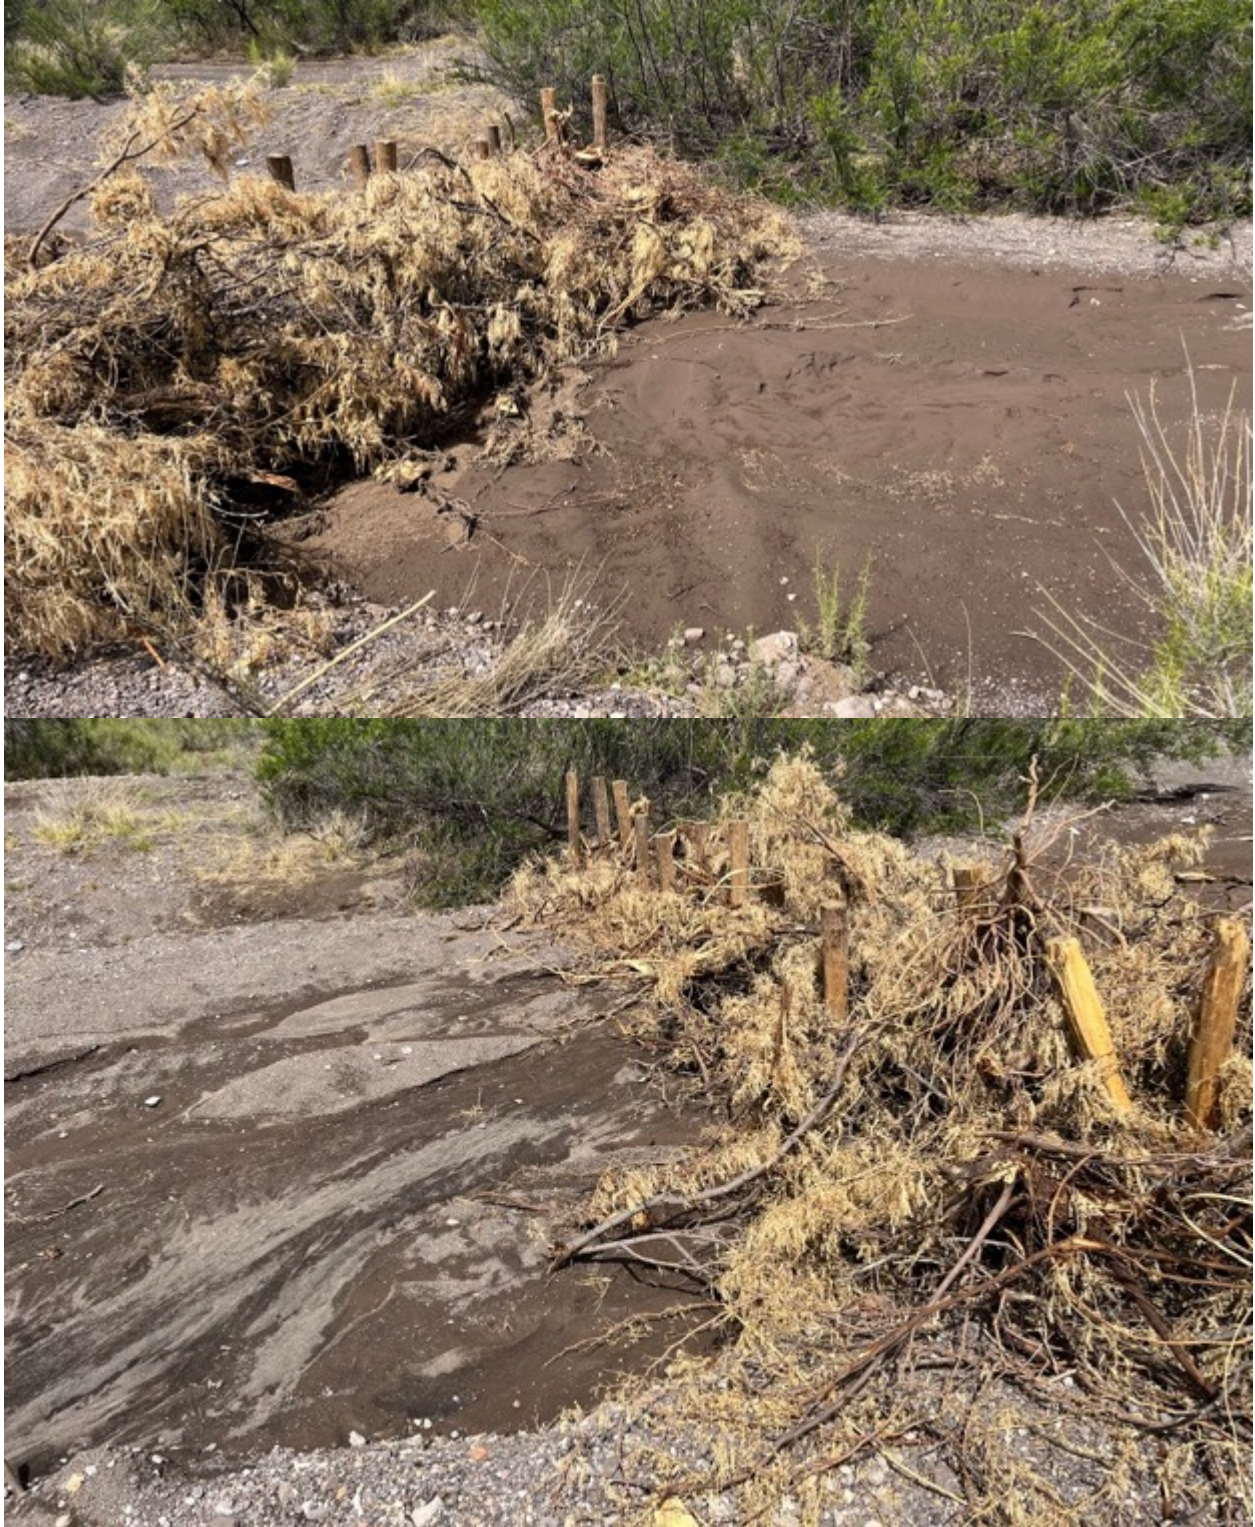
***Figure 52. Brush weirs structures show uniformly-moist soil evidence of pooling, on the upstream side of structure (top) and more unevenly-moist soil on downstream side (bottom) after water has filtered through the structure after a mid-May 2023 flow event in creek. (Photo by Philip Boyd)***

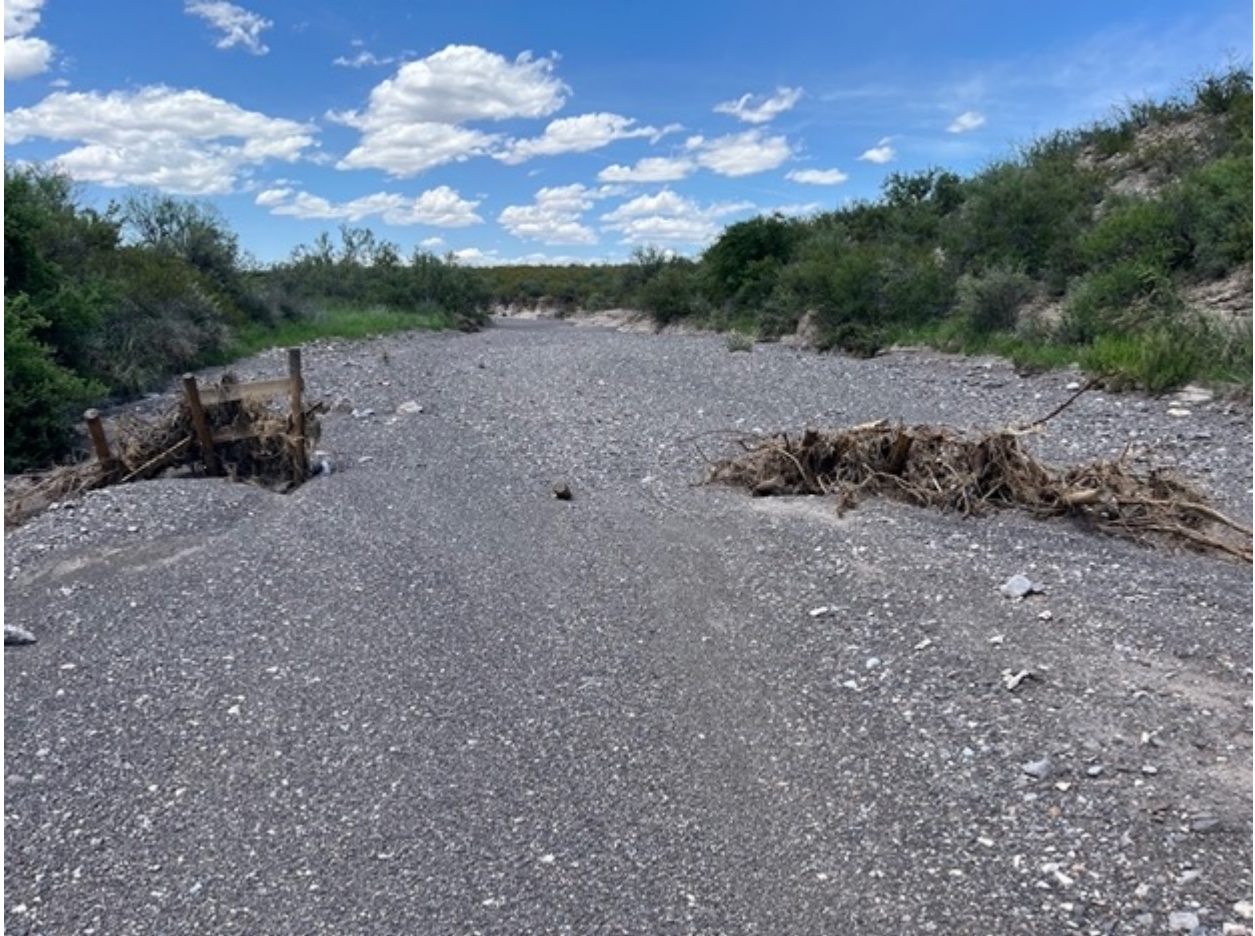
***Figure 53. Photograph showing the aftermath of a late-May 2023 flood in Matonosos Creek on the Alamito Creek Preserve. Several brush weir structures were built by the Rio Grande Joint Venture and Dixon Water Foundation with the intention of slowing water down to improve hydrological function, reduce runoff, and improve riparian habitat. This flood proved to overwhelm the structures as they were installed. The organizations plan to evaluate lessons-learned and attempt a second round of structures in 2024. (Photo by Philip Boyd)***

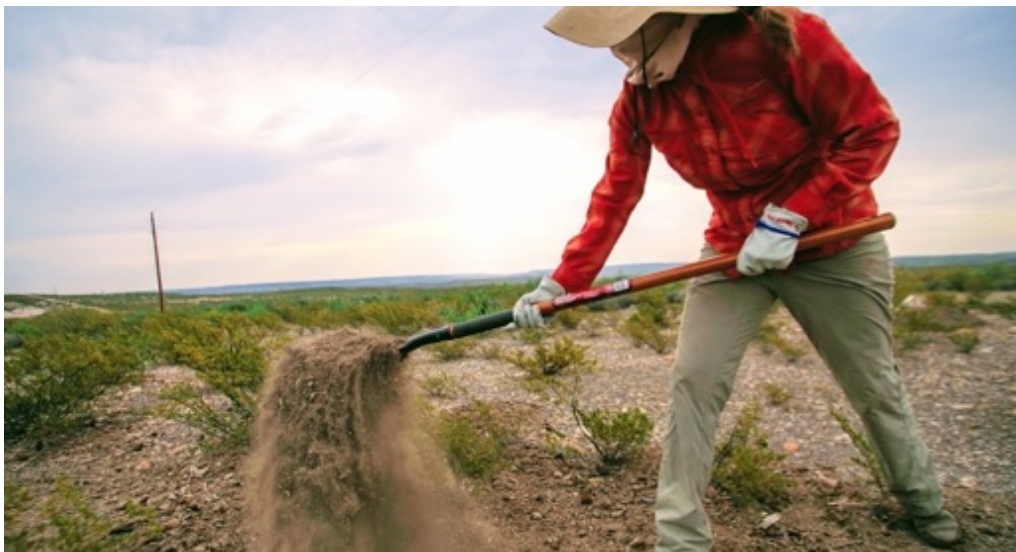
*Figure 54. Quivira Coalition staff spread compost on Alamito Creek Preserve uplands as part of a study on the benefits of biological soil amendments, Summer 2023. (Photo by Megan O'Connell)*

**Alamito Creek Preserve** – The Quivira Coalition visited West Texas in June to deploy biochar, or partially burnt biomass, and composted cattle carcasses from a local butchering facility, to plots of soil on the Preserve as a project to evaluate the potential for these amendments to benefit soil health. Some of these practices are ancient practices, but these recent efforts are aimed to study their impacts on soil health, particularly in arid regions where soil loss and drought have stressed rangelands. Foundation staff helped deploy the amendments and the Quivira team will return to continue monitoring (*Figure 54*).
